HOROTIU LANDFILL STAGE 6B: DESIGN, CONSTRUCTION & CONSTRUCTION QUALITY ASSURANCE

Nigel Edger (M.IPENZ, C.P.Eng)
Opus International Consultants Ltd
Private Bag 3057, Hamilton

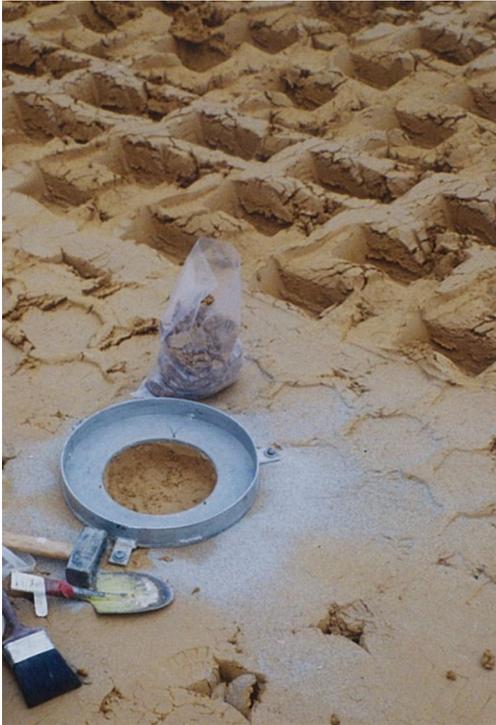
Figure 3: CCL during construction

The Contractor generally spread the delivered soil using a bulldozer then compacted it with an 18t sheepsfoot roller. Water carts were used to wet the soil when required, especially during summer when the exposed surface dried very quickly. Frequent re-work was needed to repair desiccation cracking. During winter, it was virtually impossible to dry the clay once it got too wet to compact, as the rate of drying was very slow and frequent rainfall re-wetted the soil. Drying was successful in summer. Thin plastic (silage wrapping) was used successfully to prevent drying of the CCL, and with somewhat less success to prevent wetting during rain.

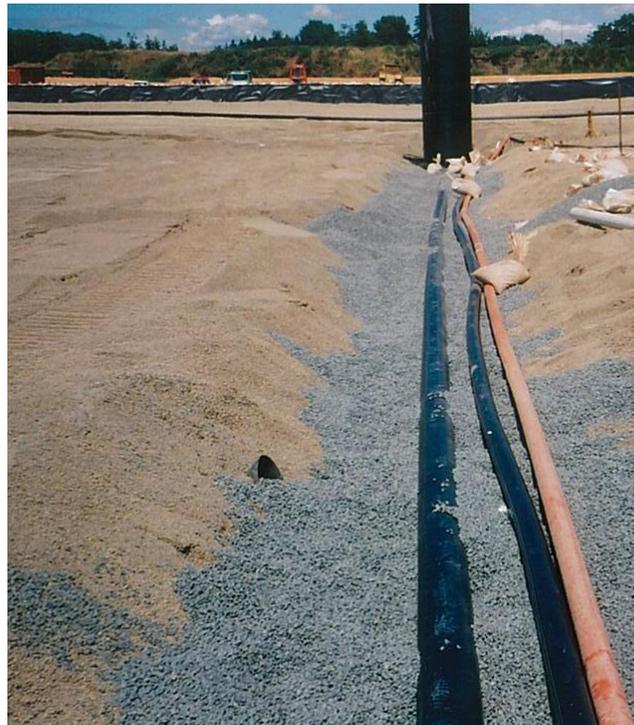
Figure 4: Leachate drainage blanket, central drain, chamber, rising main and cable duct

Placing the leachate drainage blanket was fairly straightforward and went well. Figure 4 shows a photo of the drainage blanket, the central leachate drain and chamber, the rising main and electrical duct and the herringbone gravel drains.

- Lateral floor slopes of 2% and longitudinal floor slopes of 1%
- A 300mm thick leachate collection layer of well graded sand/gravel
- Gravel strip drains in a herringbone pattern at 20m intervals across the base (normal to the contours). Bidim A44 geotextile under the gravel protects the liner from damage.
- A central 160mm diameter HDPE leachate collection drain
- a 1.5m diameter HDPE pump chamber at the low point.
