Design considerations for steep wall liners in landfills

Simonne Eldridge Jonathan Shamrock

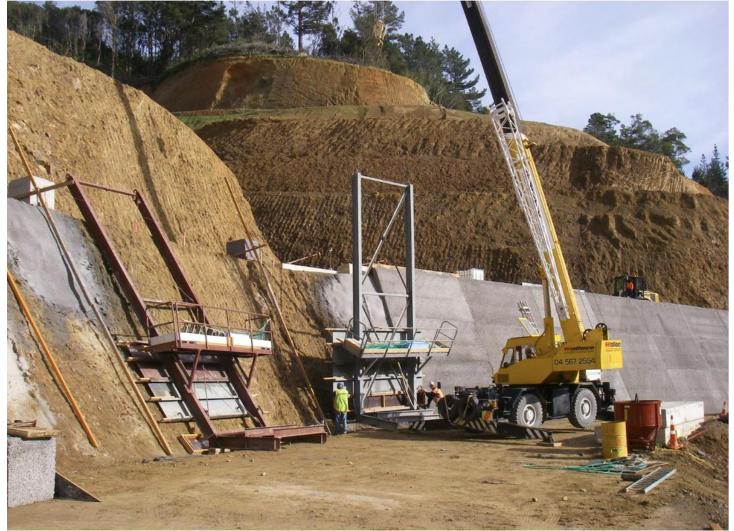
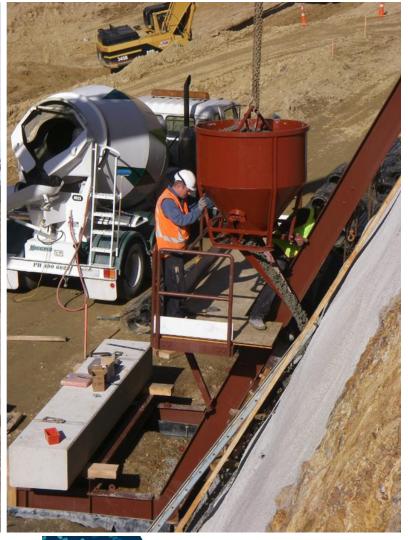
No fines cast against excavated face

- Steep rock slopes are on 1V in 0.5H with a 6 m inter-bench height
- The greywacke rock quality varies from fresh rock through to fractured and slightly weathered
- On completion, the total waste depth will be in the order of 100 m

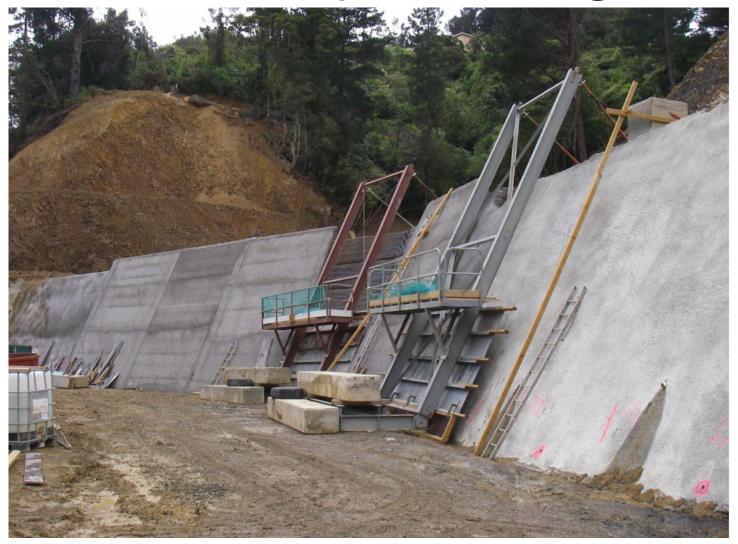
No fines completed subgrade

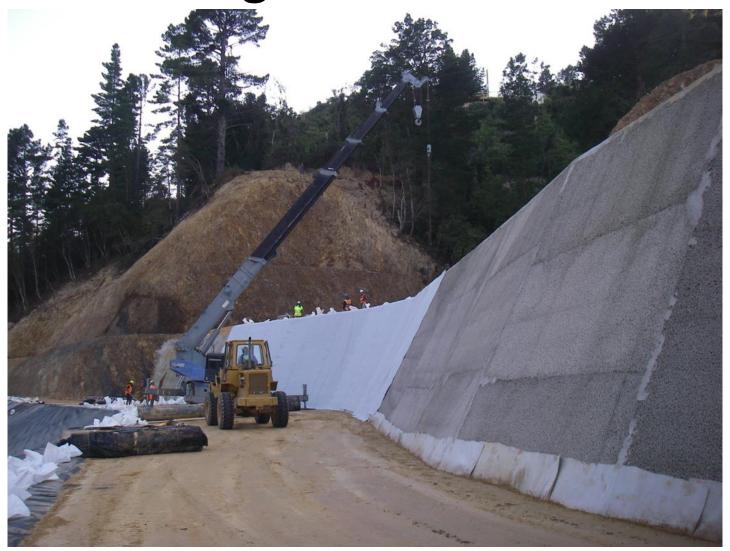
Protection geotextile installation

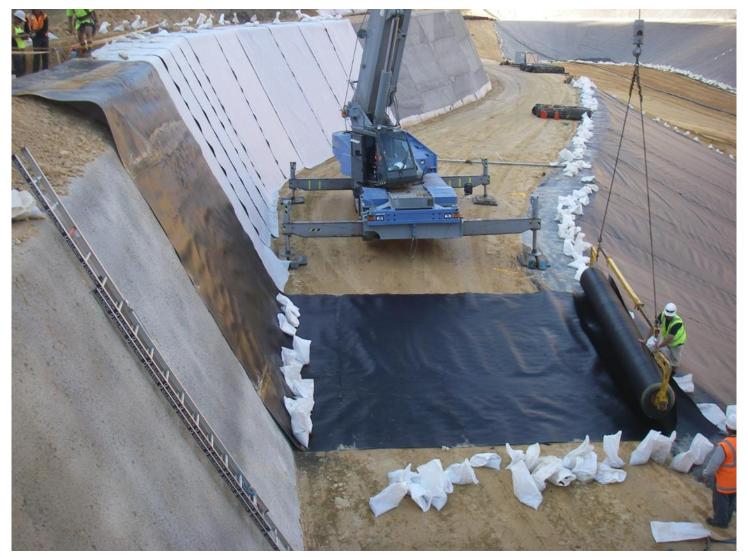
Geomembrane installation

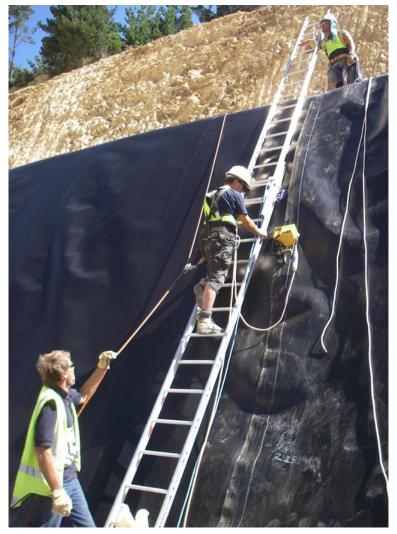
Geomembrane welding

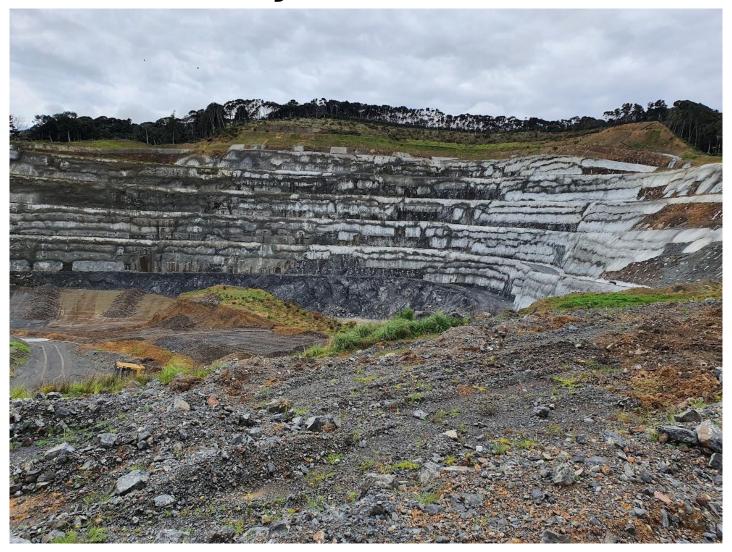
Quarry stabilisation

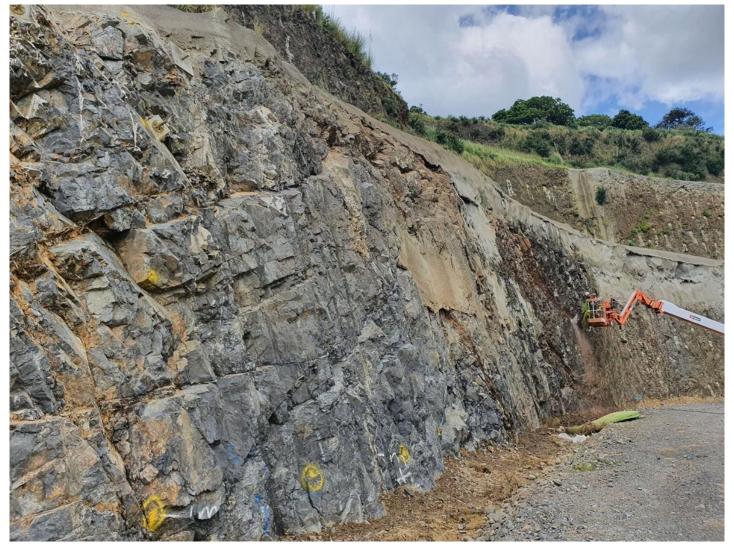
Quarry excavation surface preparation

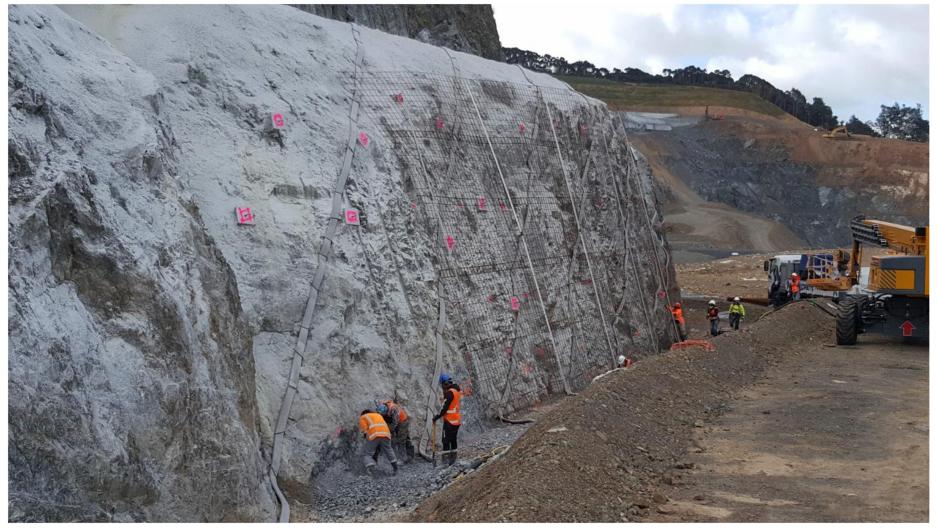
Hook bolts, strip drains, supporting mesh, screed rails

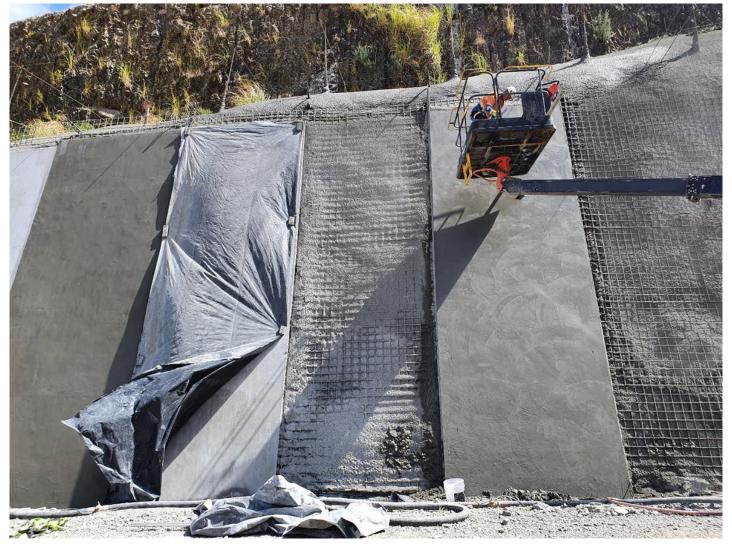
Panel installation between screed rails

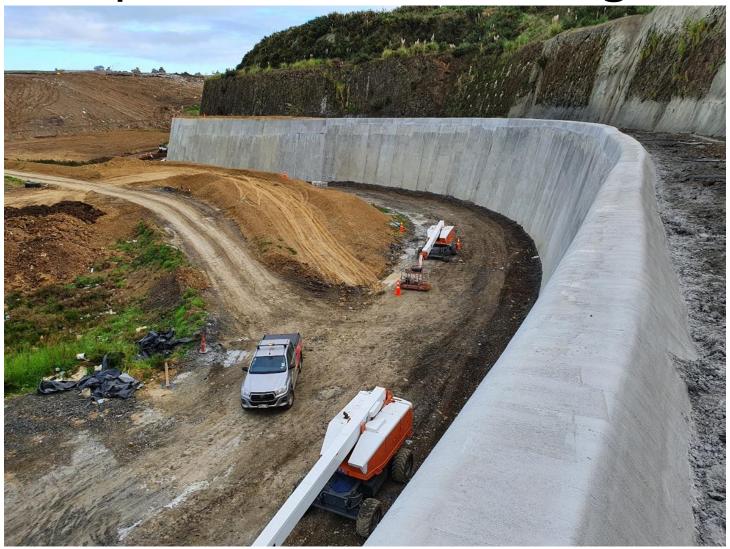
Completed shotcrete subgrade

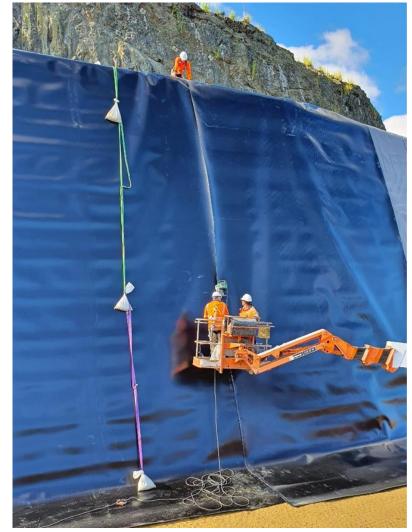
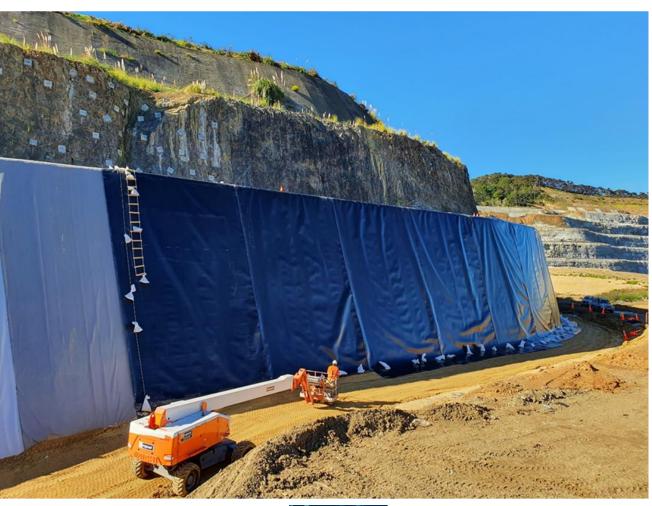
Geomembrane installation

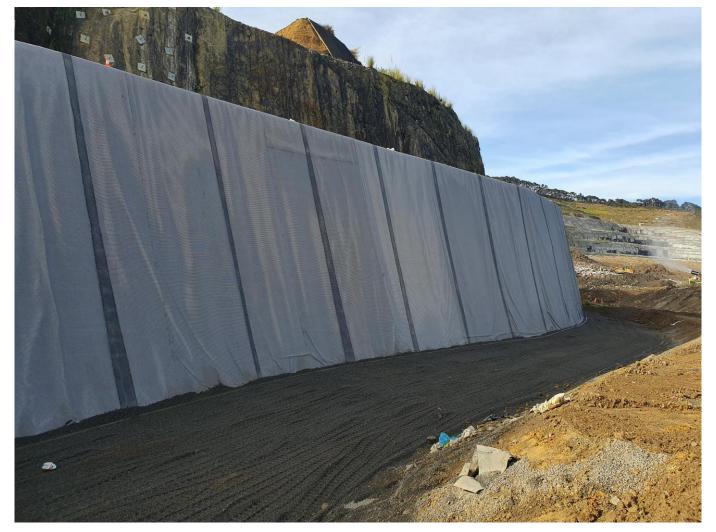
Protection and leachate drainage layer installation

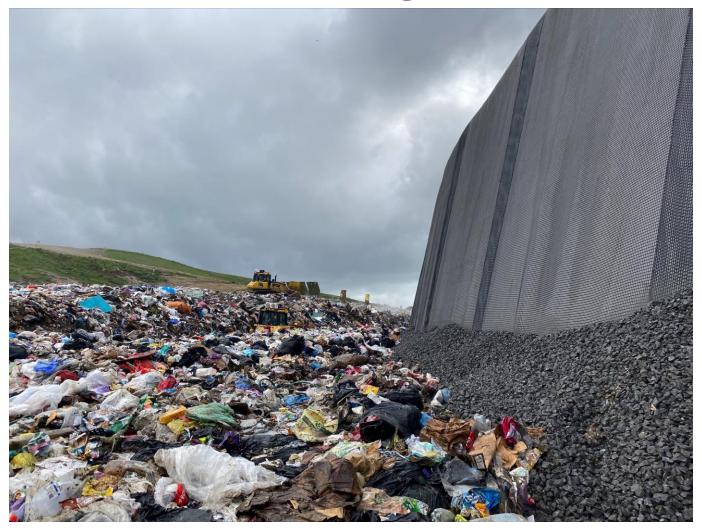
Filling

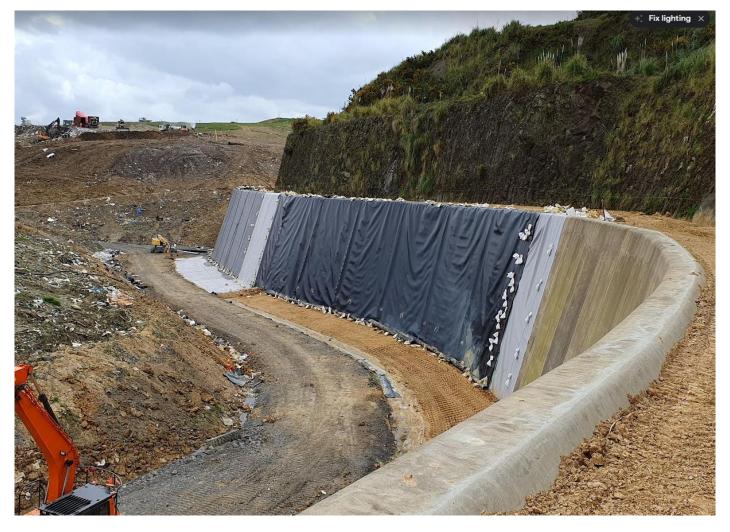
Staged construction as waste filling progresses

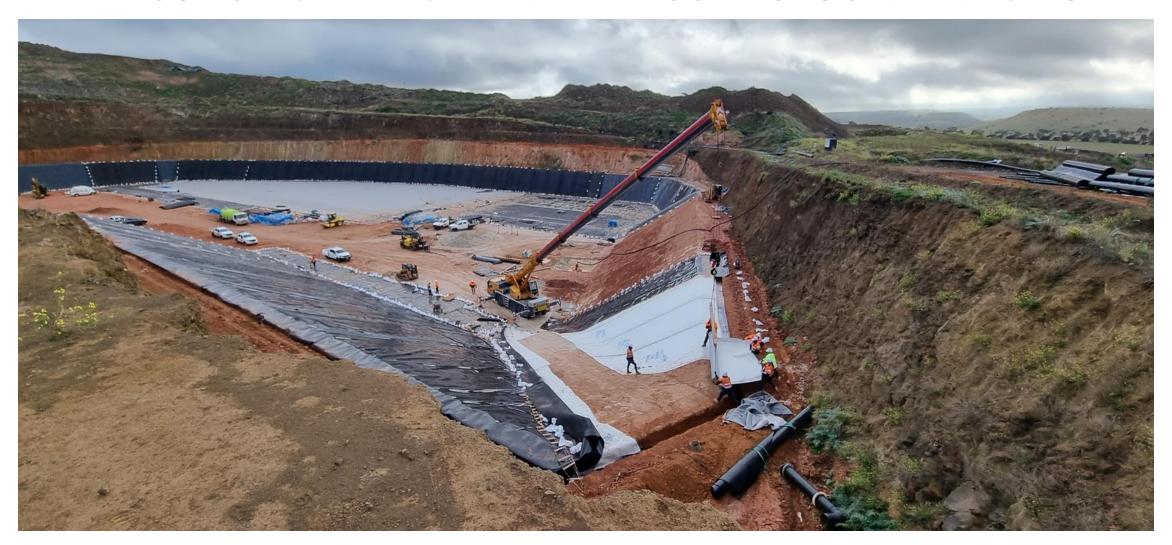
Excavation into in-situ weathered siltstone

- Steep excavated soft rock slopes are on 1V in 0.5H with a 10 m inter-bench height, 5 m wide benches
- First bench in excavated soft fine grained rock
- Upper lifts, in more blocky weathered material, to have steep compacted clay liner installed

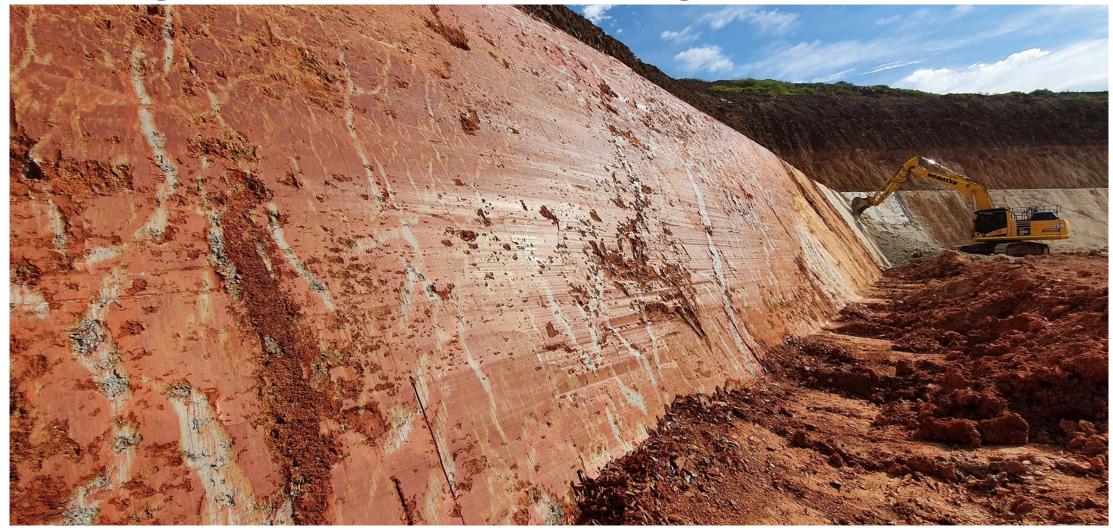
Subgrade preparation fine grained soft rock

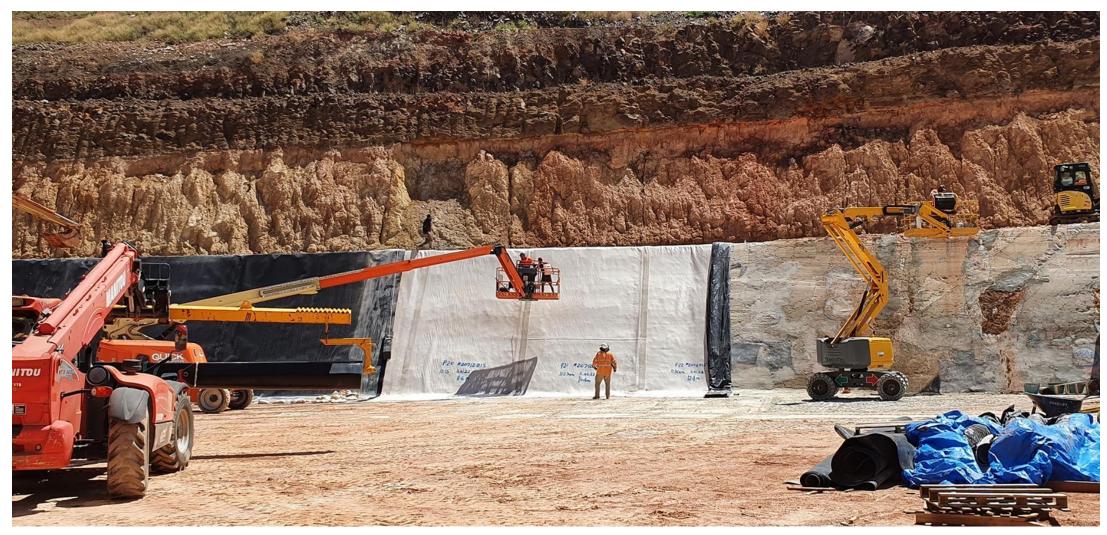
Composite GCL/HDPE installation
