When the river runs orange

Orange plume – Ohinimuri River

23 August 2024

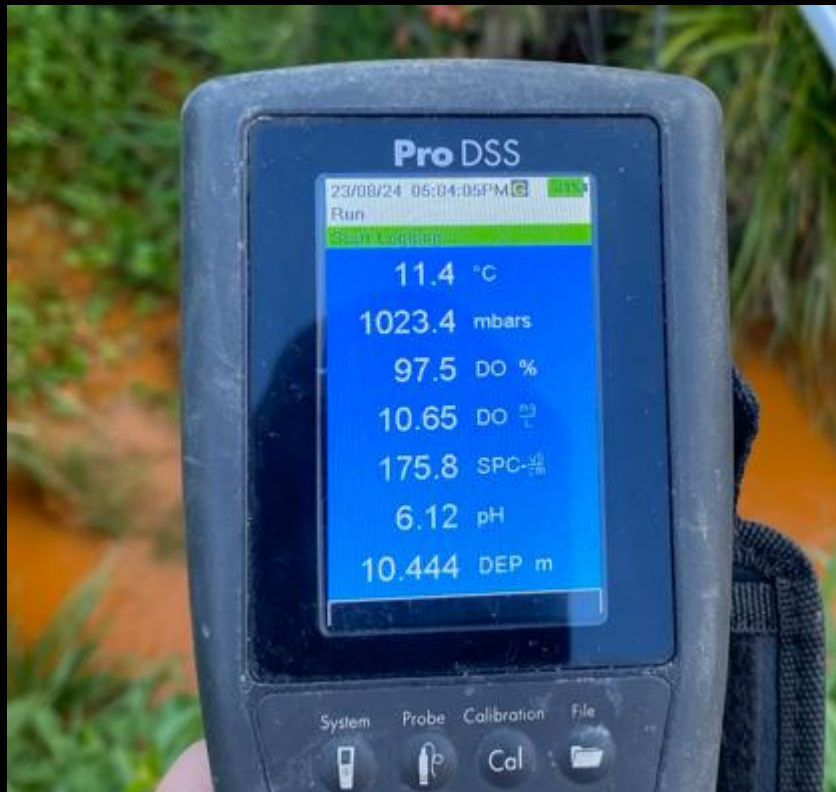
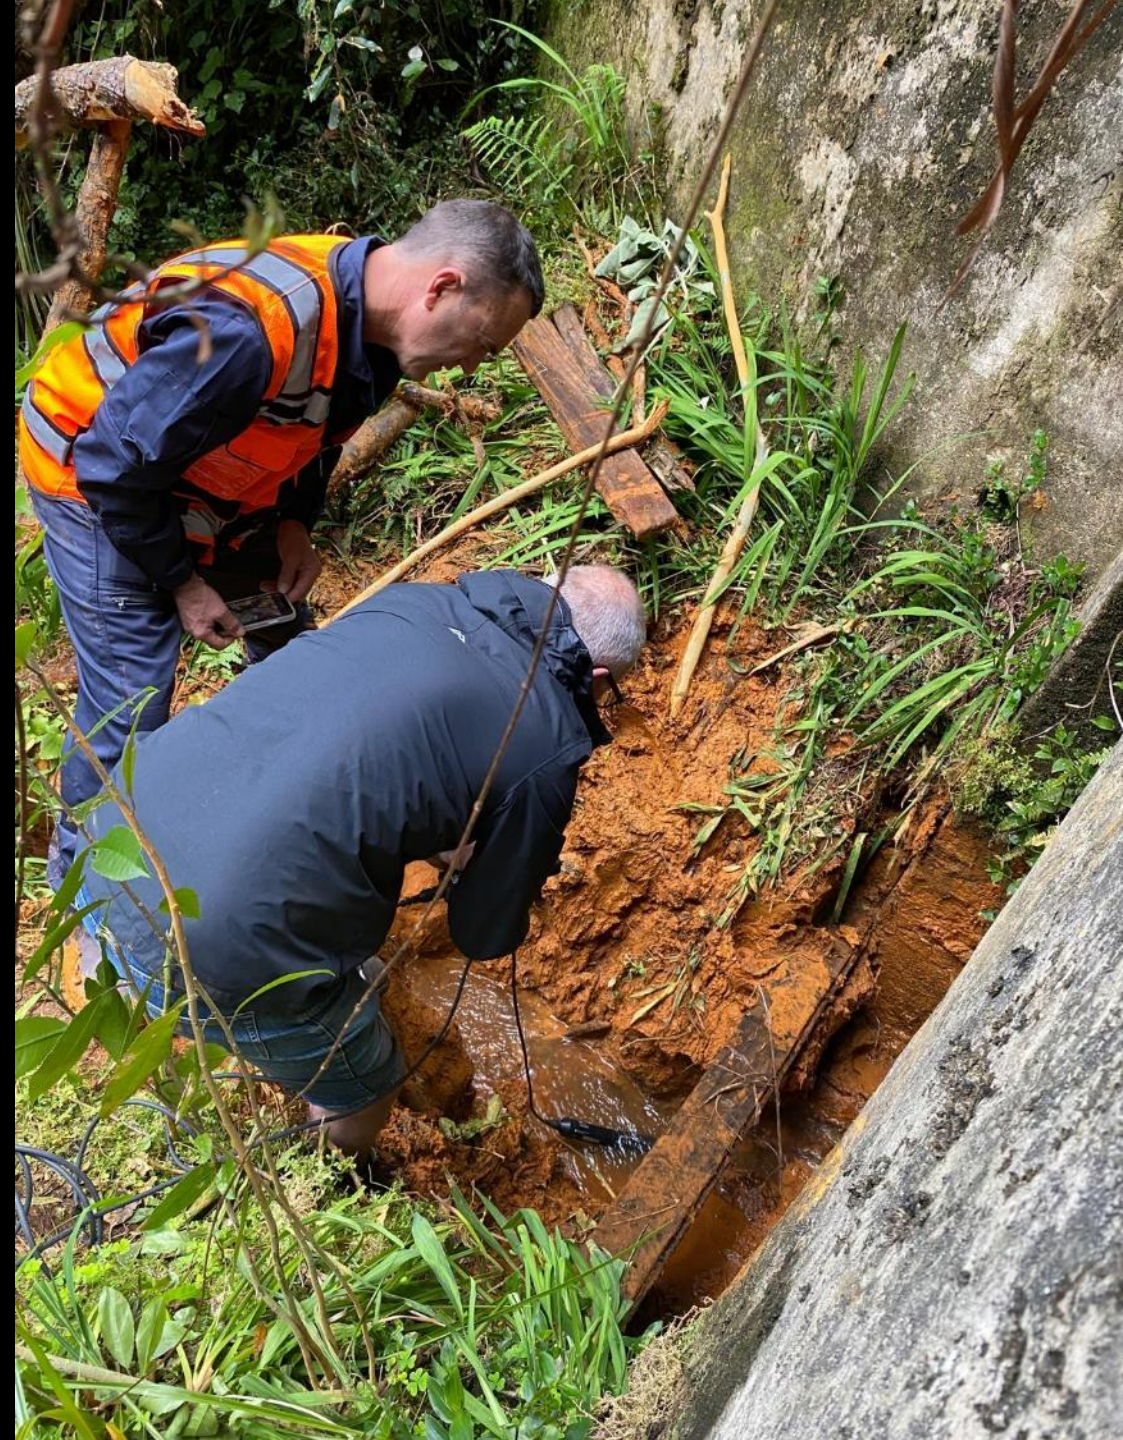
Field results

- Stream & mine pH 6.1-6.2
- River pH 6.9-7.1
- Dissolved oxygen good

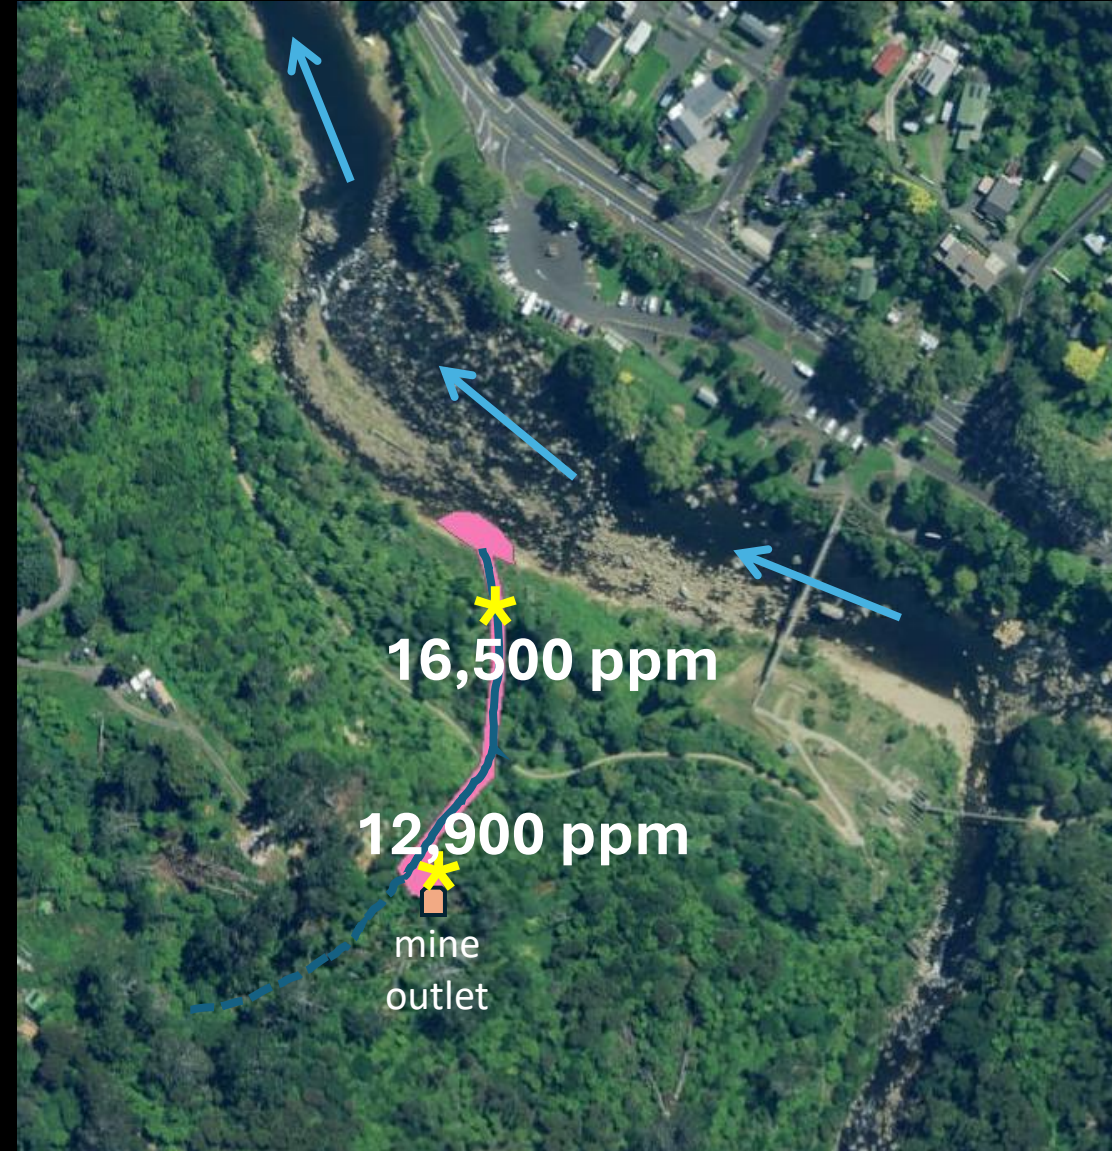
Sediment sample lab results

- High As & Fe
- High Sb (34 to 45 ppm)
- Hg, Pb and other metals within regional background levels
- Cyanide detected but well below health risk
