# AN UNPALATABLE COCKTAIL OF PFAS AND ASBESTOS

# PROJECT OVERVIEW

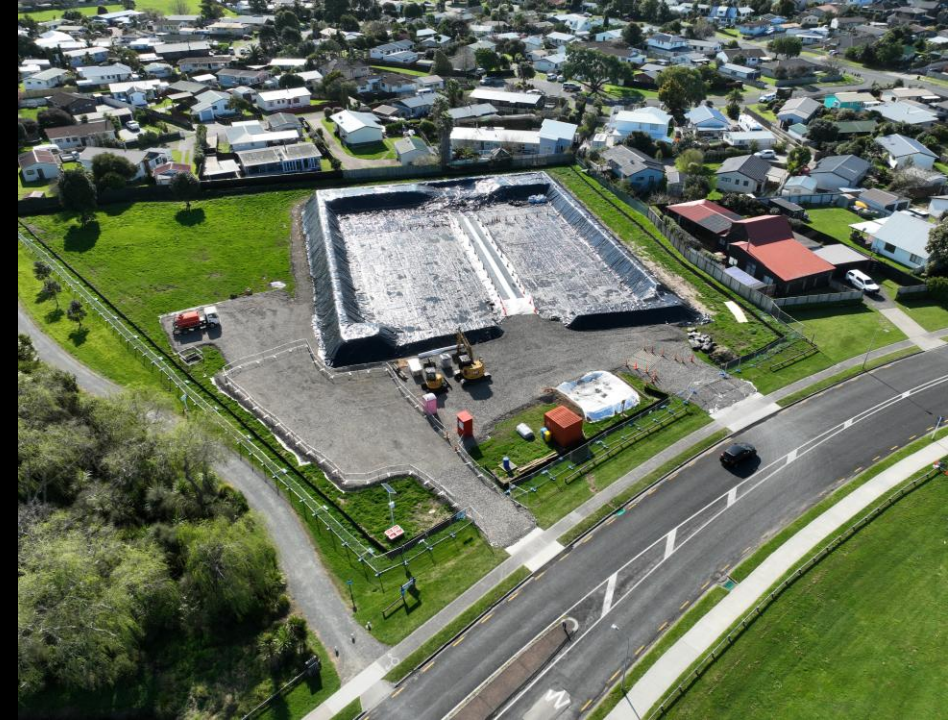
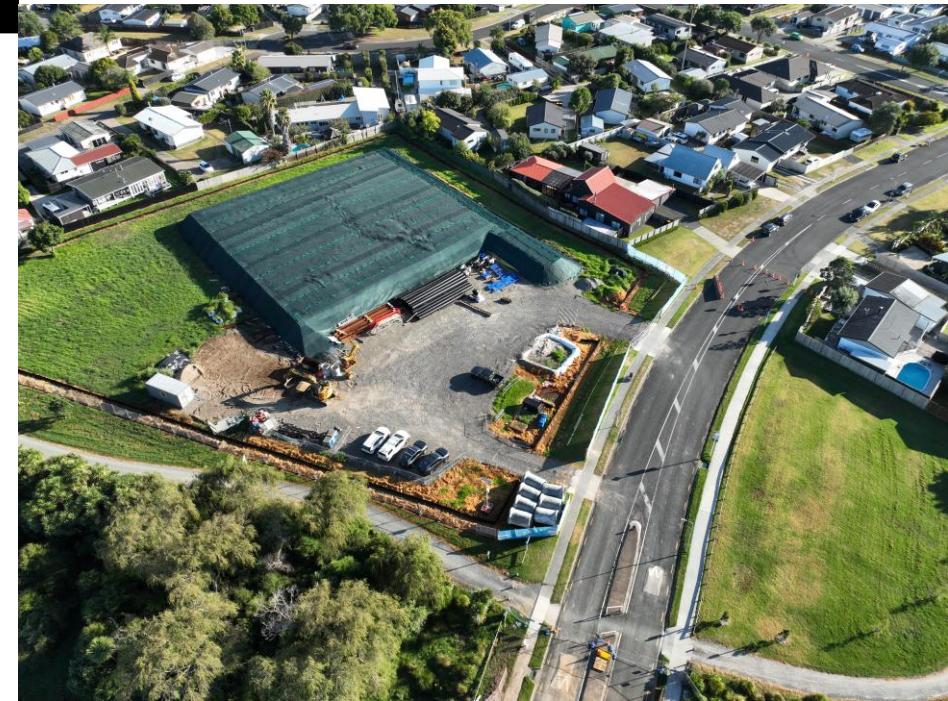
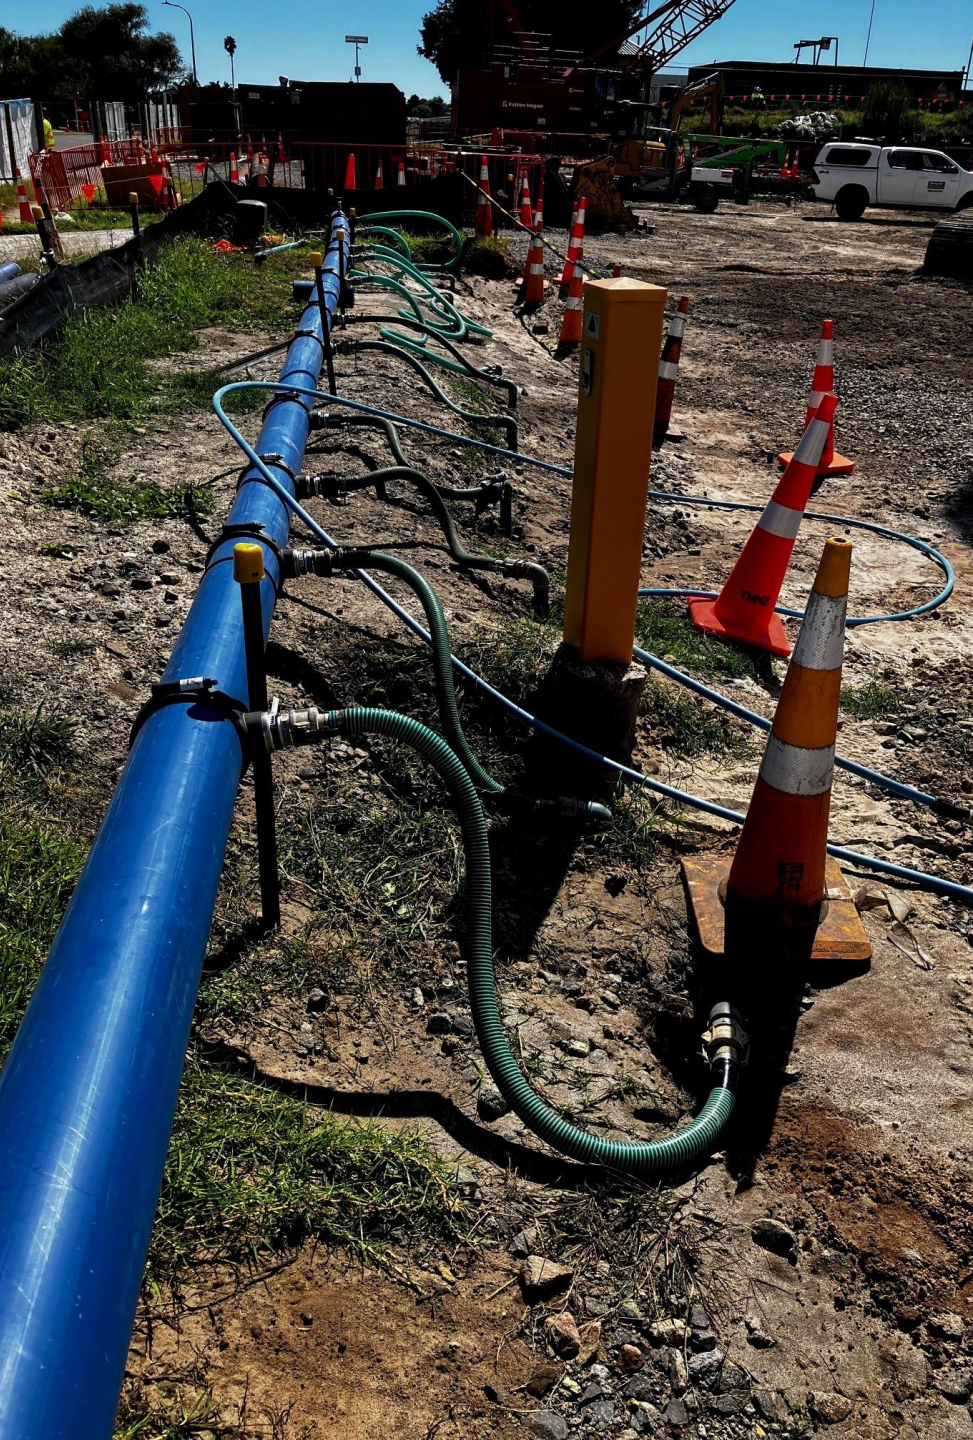
# RISKS – PFAS IN SOILS

- Temporary storage area for PFAS contaminated soils
  - No economically feasible disposal route for PFAS contaminated soil
- Additional PFAS sampling
  - Maximum concentration of Total PFHxS and PFOS 0.004mg/kg

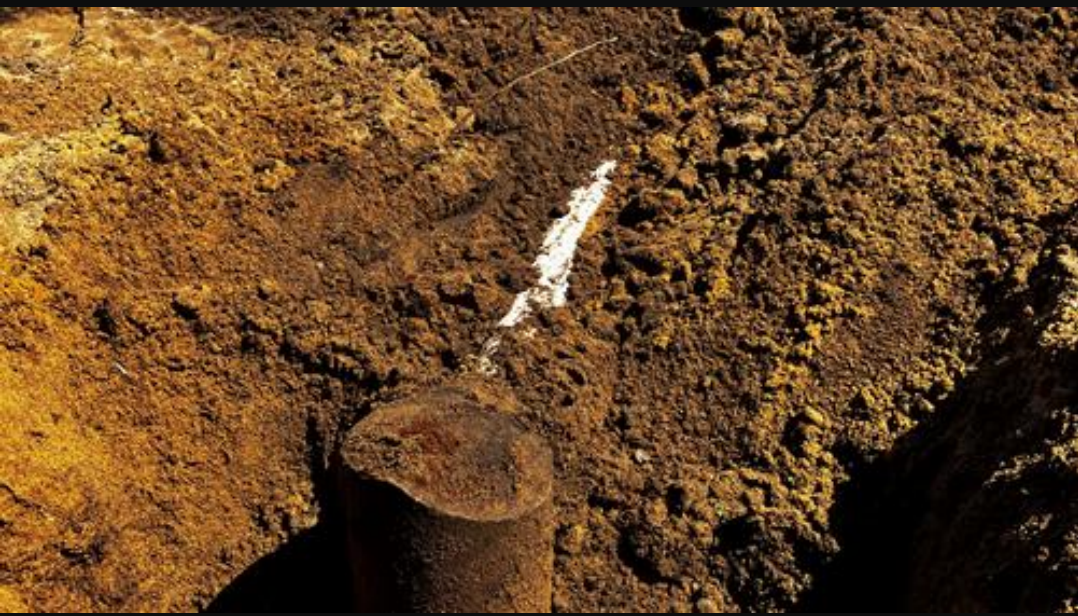
# RISKS – PFAS IN GROUNDWATER

- Dewatering likely required for 6-9 months
- Sampling undertaken post project commencement
- Total PFOS present
- Exceeds LOR, below the ANZG 95% species protection level for freshwater.
- Further challenges for PFAS contaminated water disposal
- Only option – Re-injection spears boundary of site

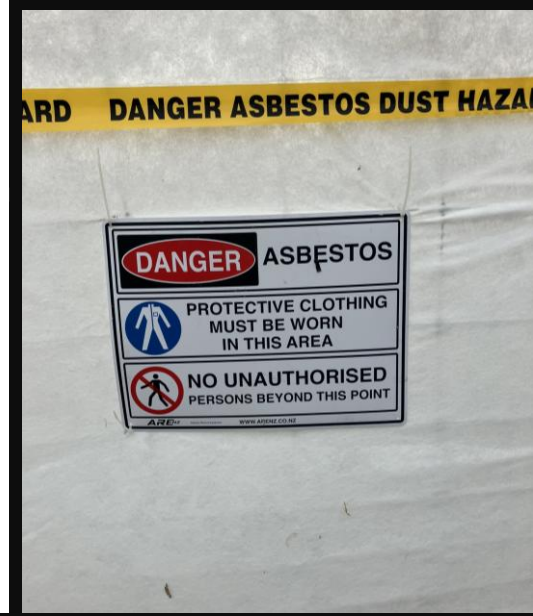
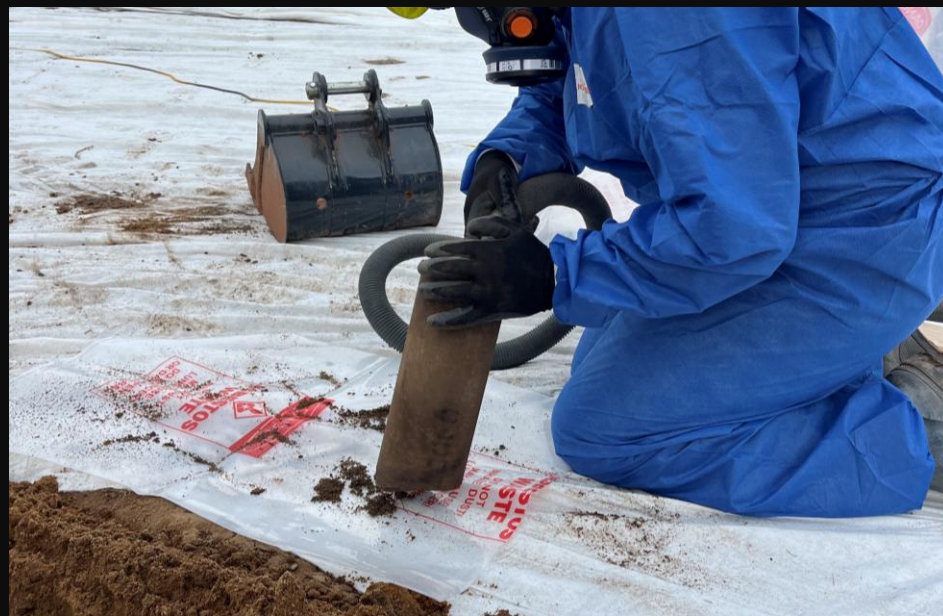
# ASBESTOS - UNEXPECTED DISCOVERY

- Asbestos unexpected discovery during subsoil removal
- Bulk analysis of ACM- Amosite and Chrysotile asbestos
- Asbestos in soils maximum concentration ACM 0.4179 w/w% and maximum concentration AF/FA 0.0016%
- Additional regulatory compliance and mitigation measures
