Sawdust and sandcastles: A tale of unexpected contamination

Miles Calder (Senior Environmental Scientist)
Sarah Guy (Environmental Consultant)

Site History and Project Overview

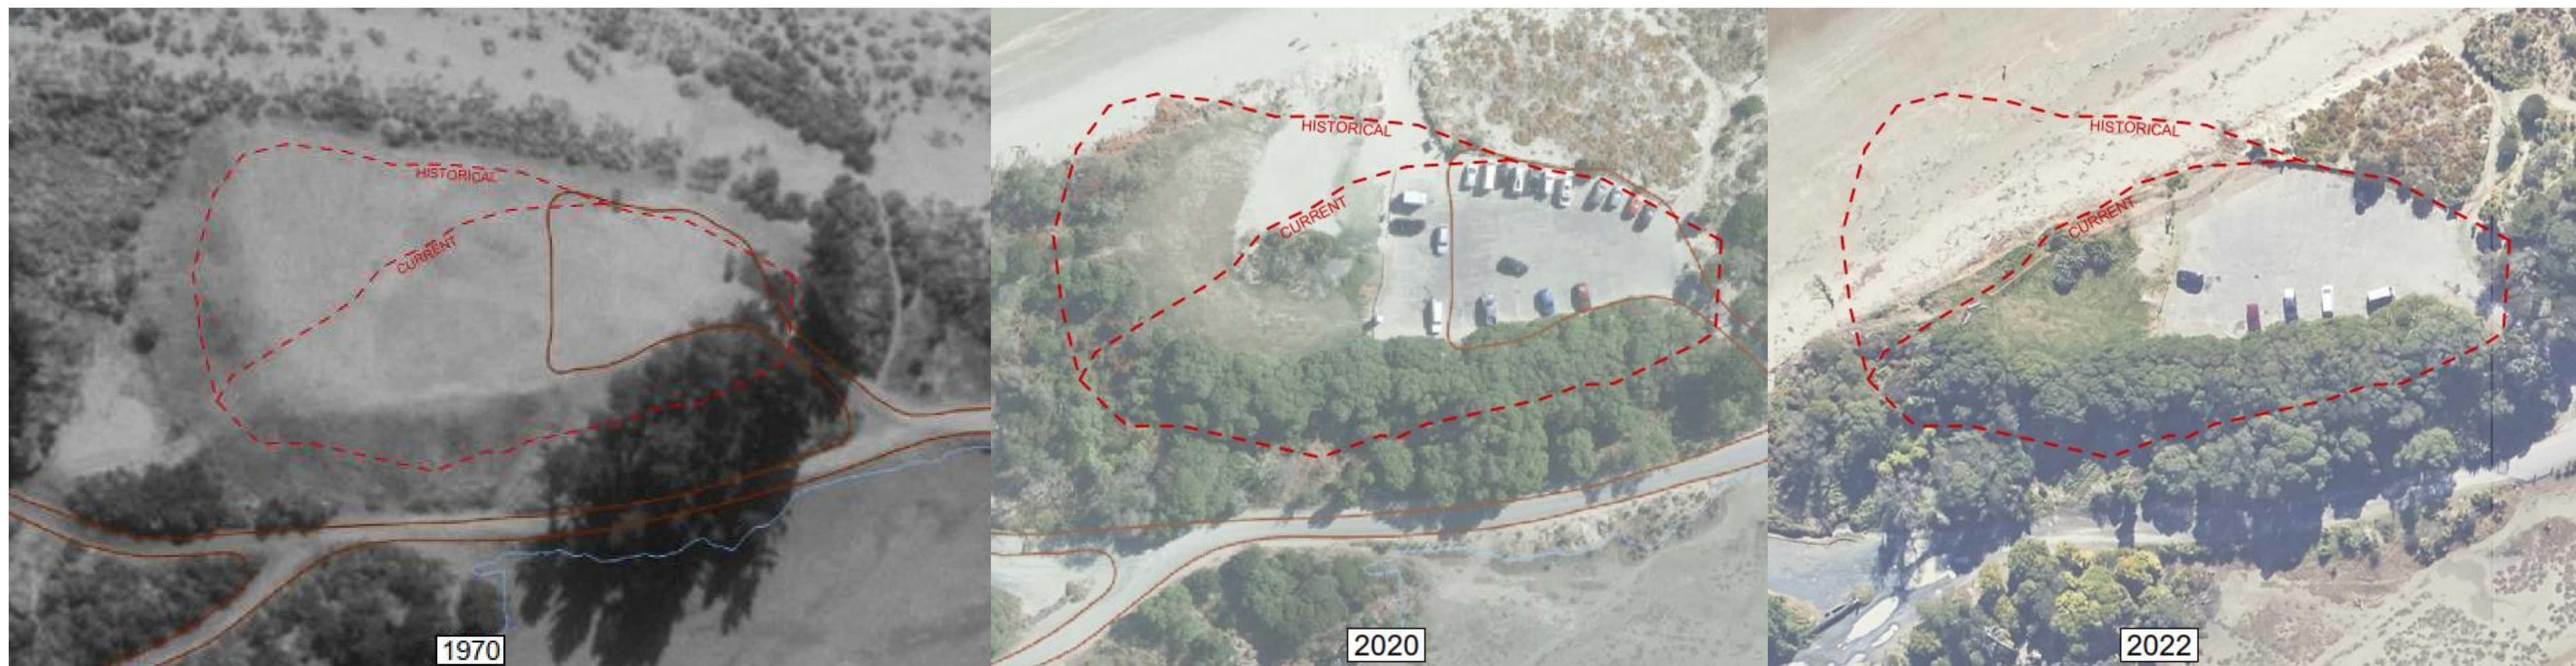
- Wood waste from Nelson sawmills used in 1960s to reclaim an elevated area for car park
- Eastward movement of Blind Channel gradually eroded site. Sawdust began to appear in 2019, with a large release in 2022
- Contaminant testing in mid 2023 confirmed sawdust was CCAB and PCP treated and estimated 5,900m³ buried material

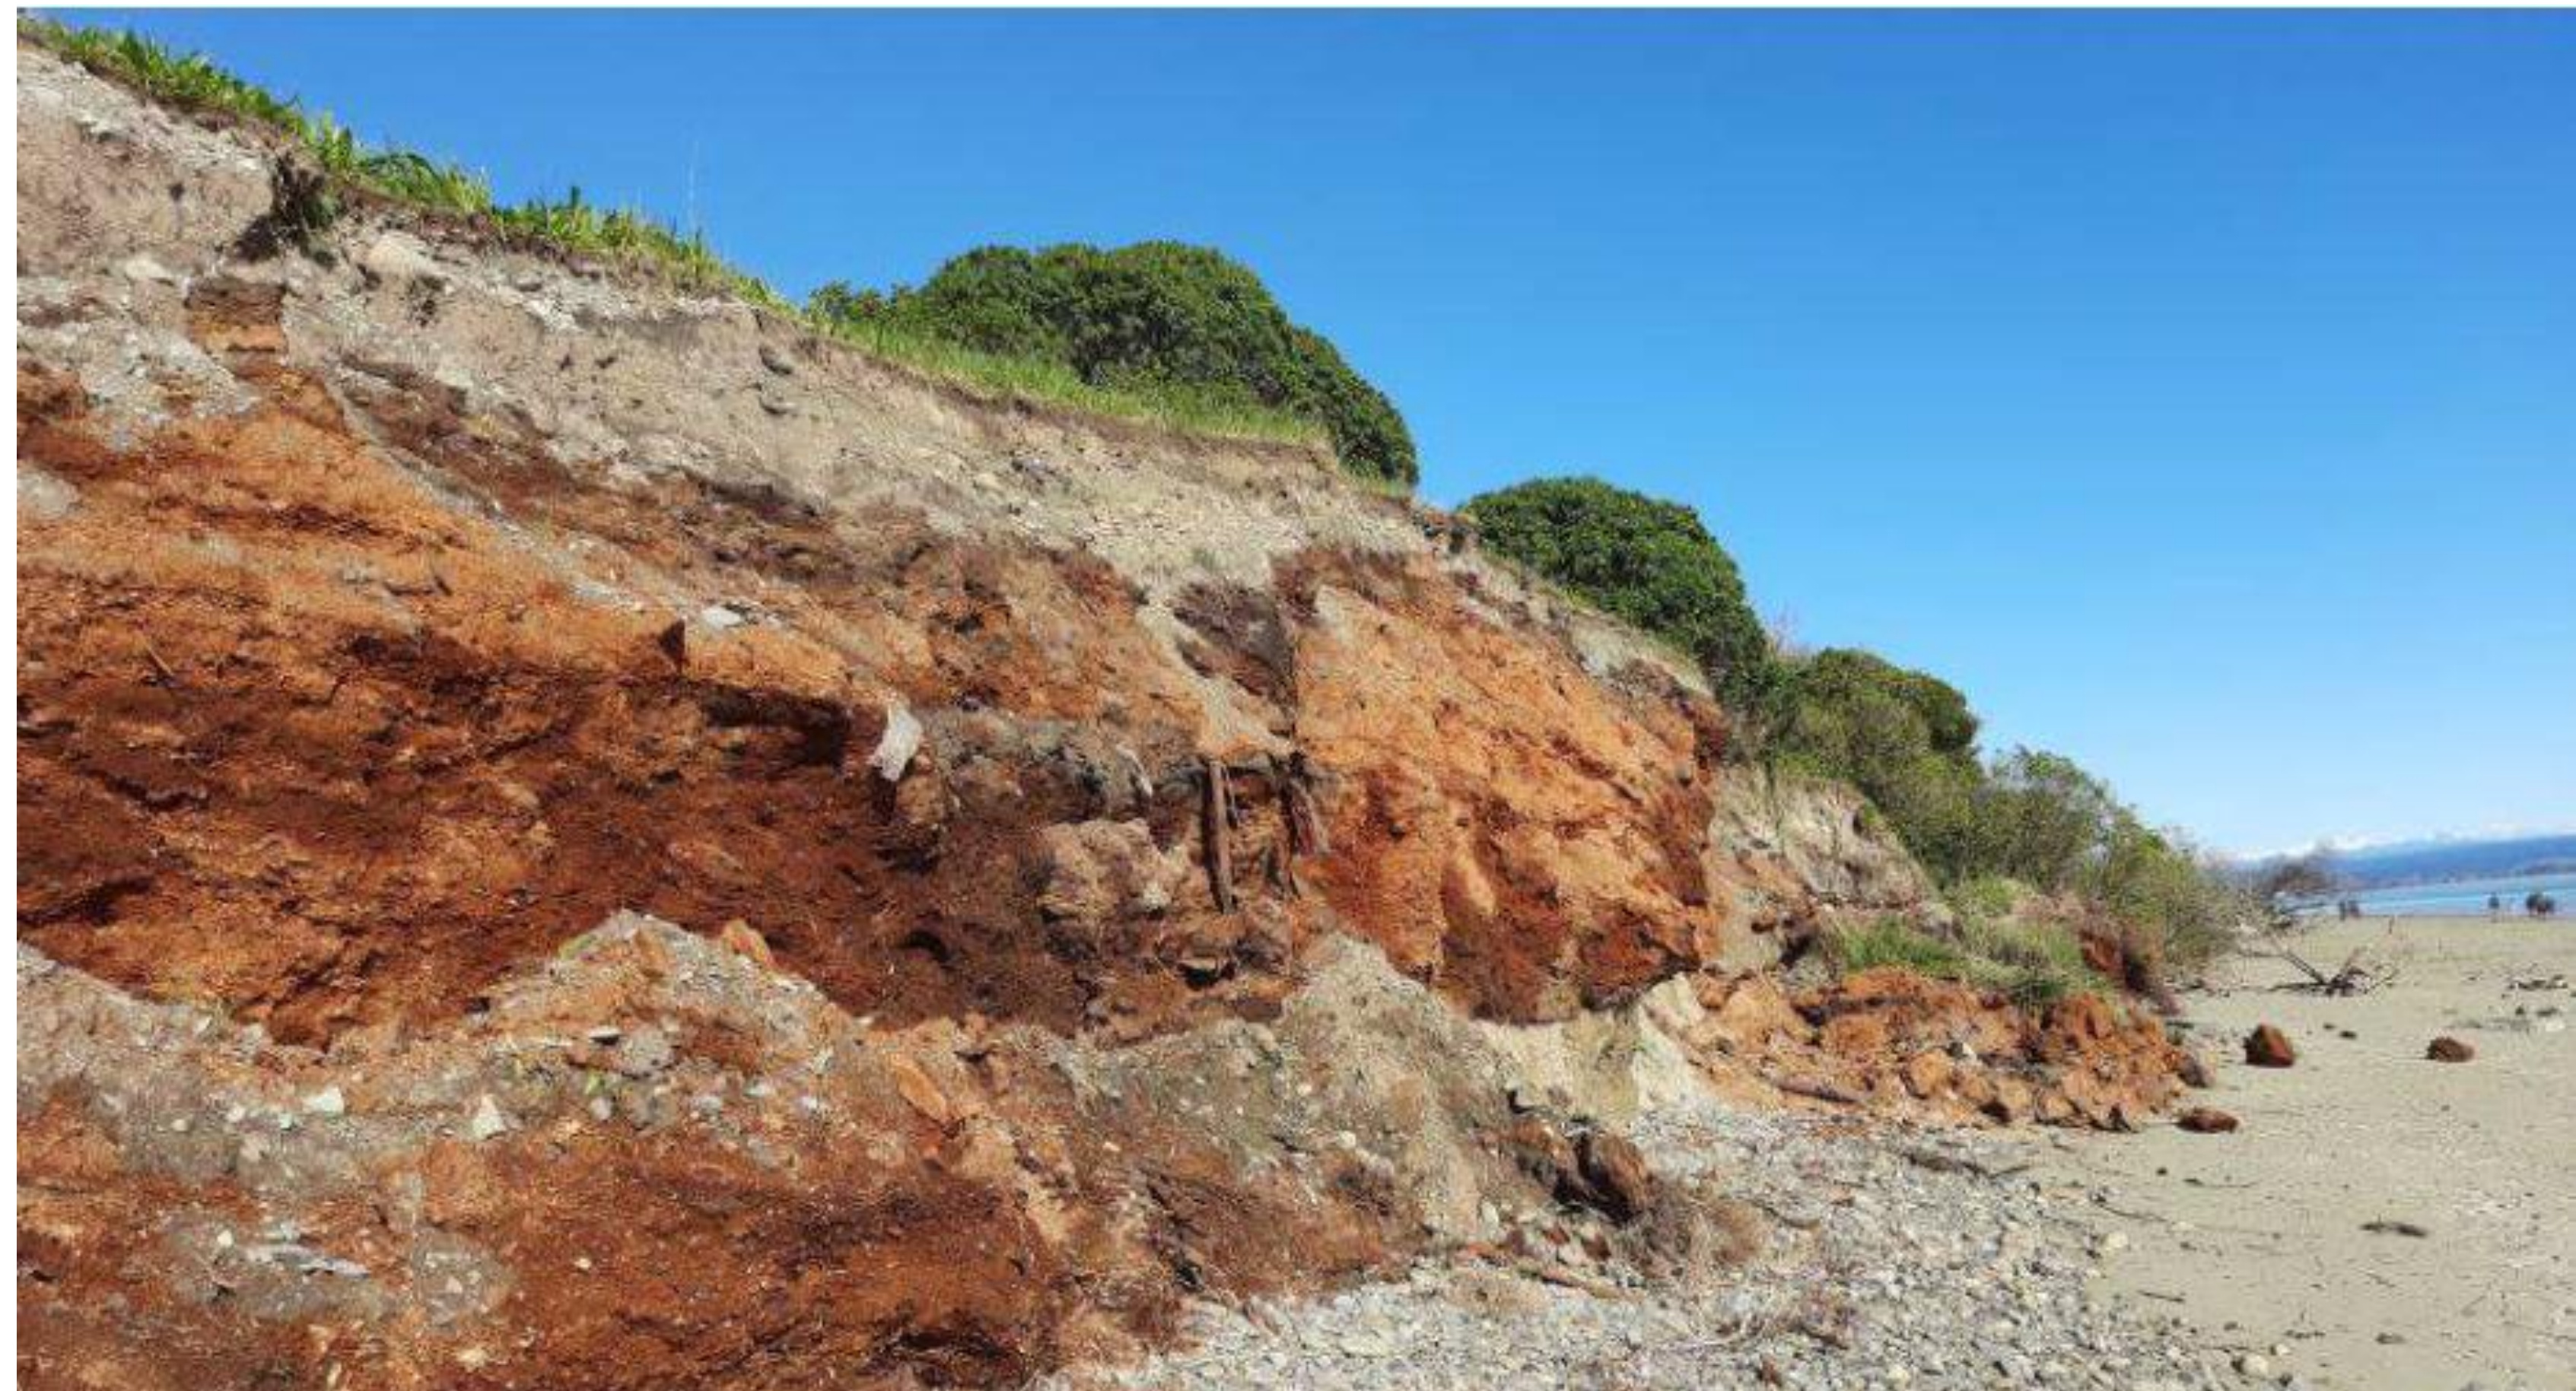
Sawdust with high levels of heavy metals shuts off part of Tāhunanui Beach

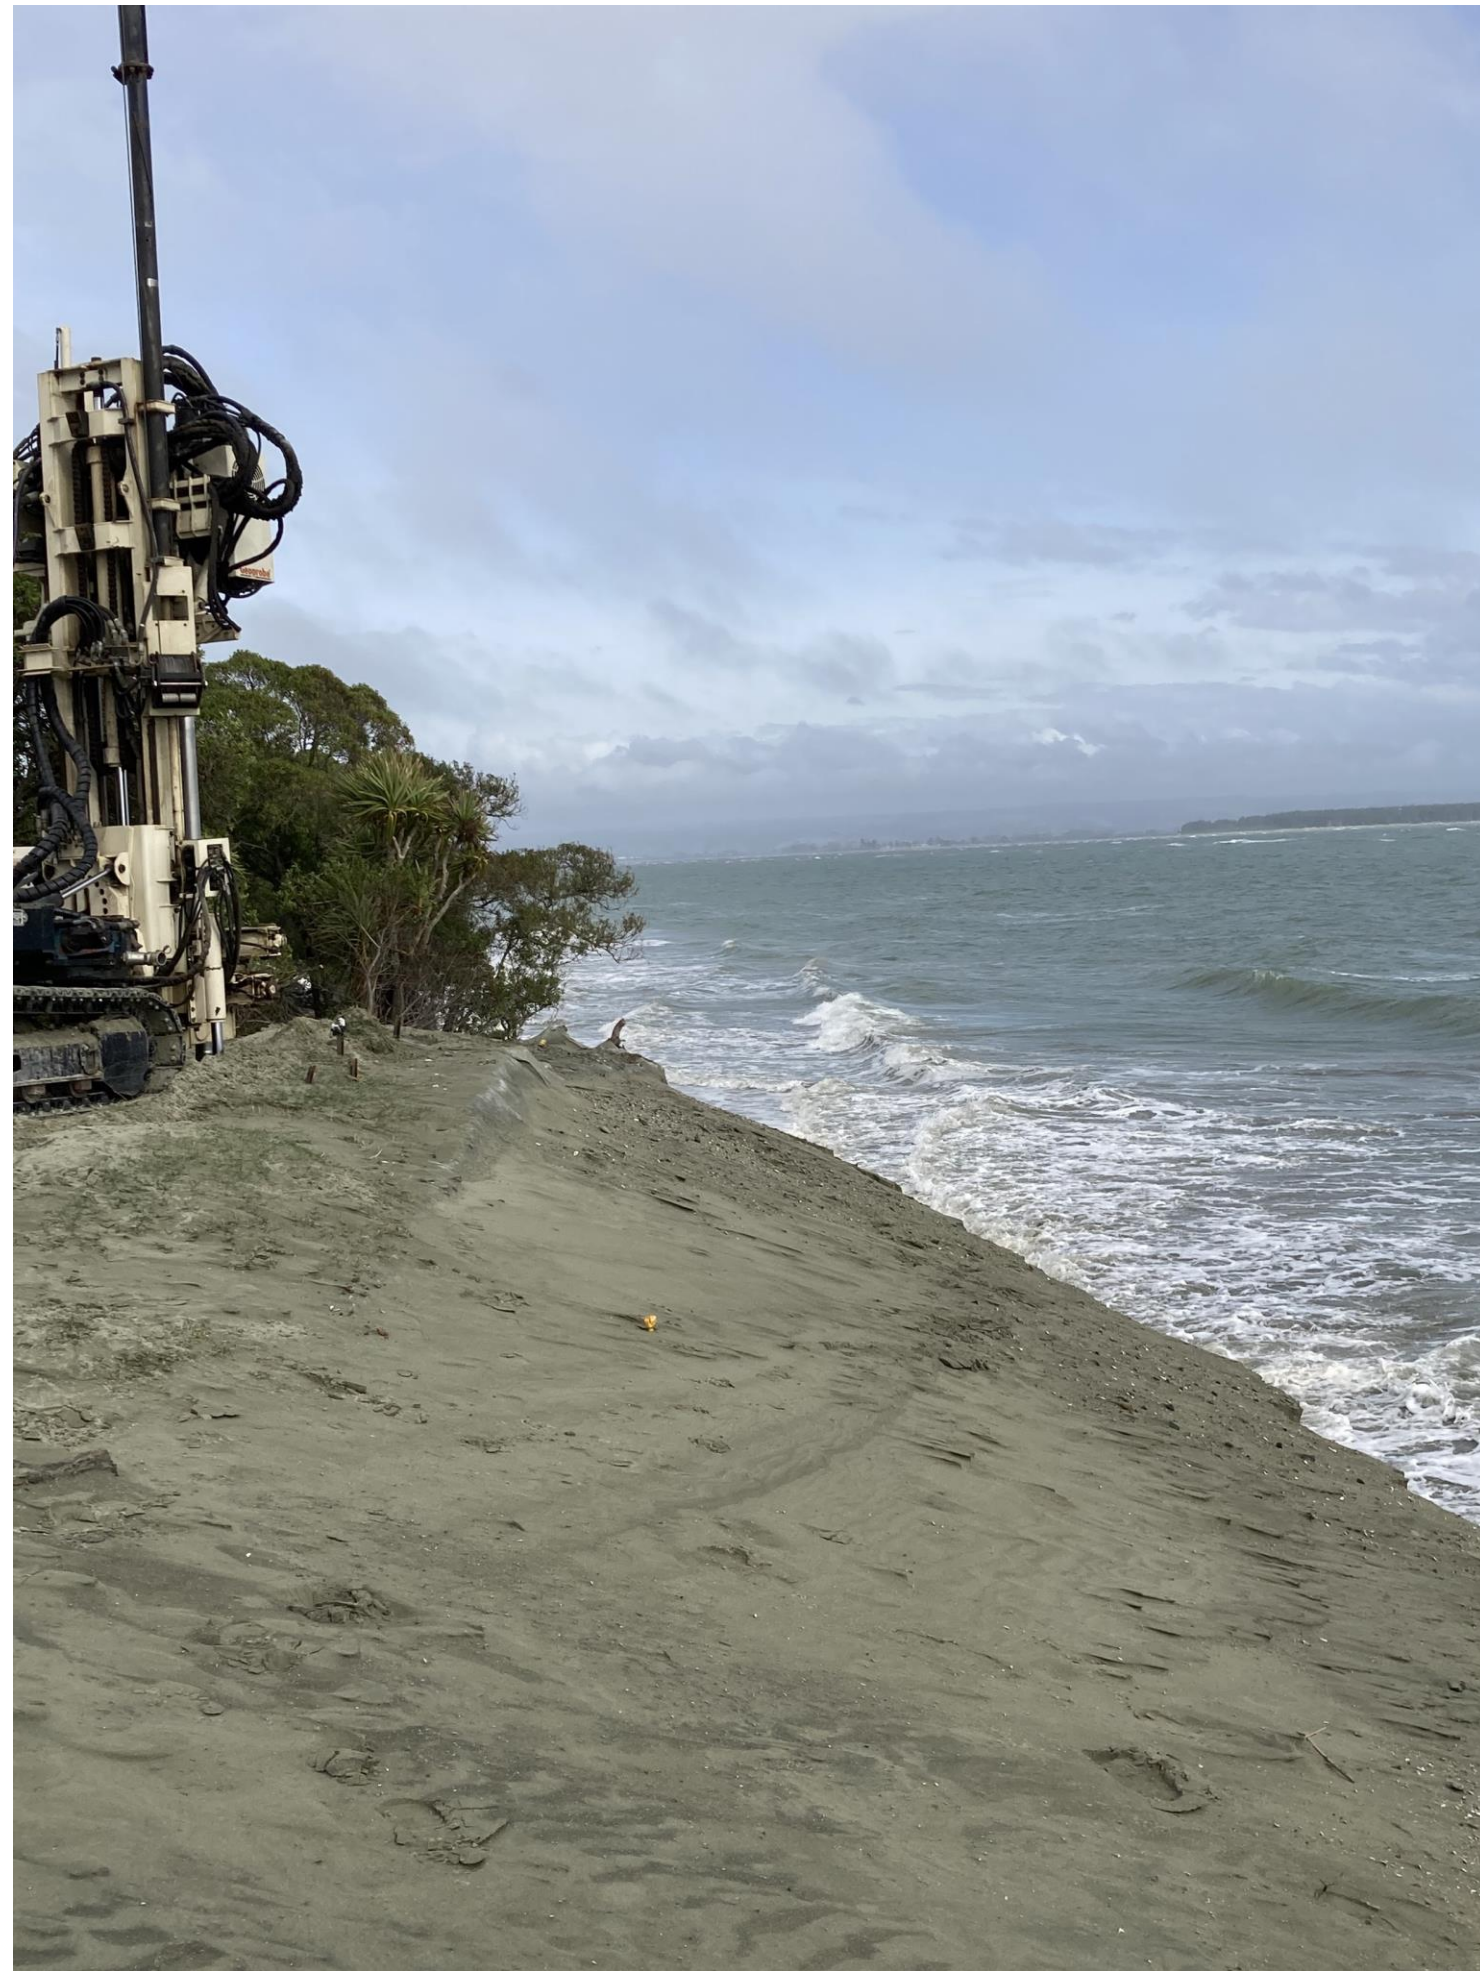
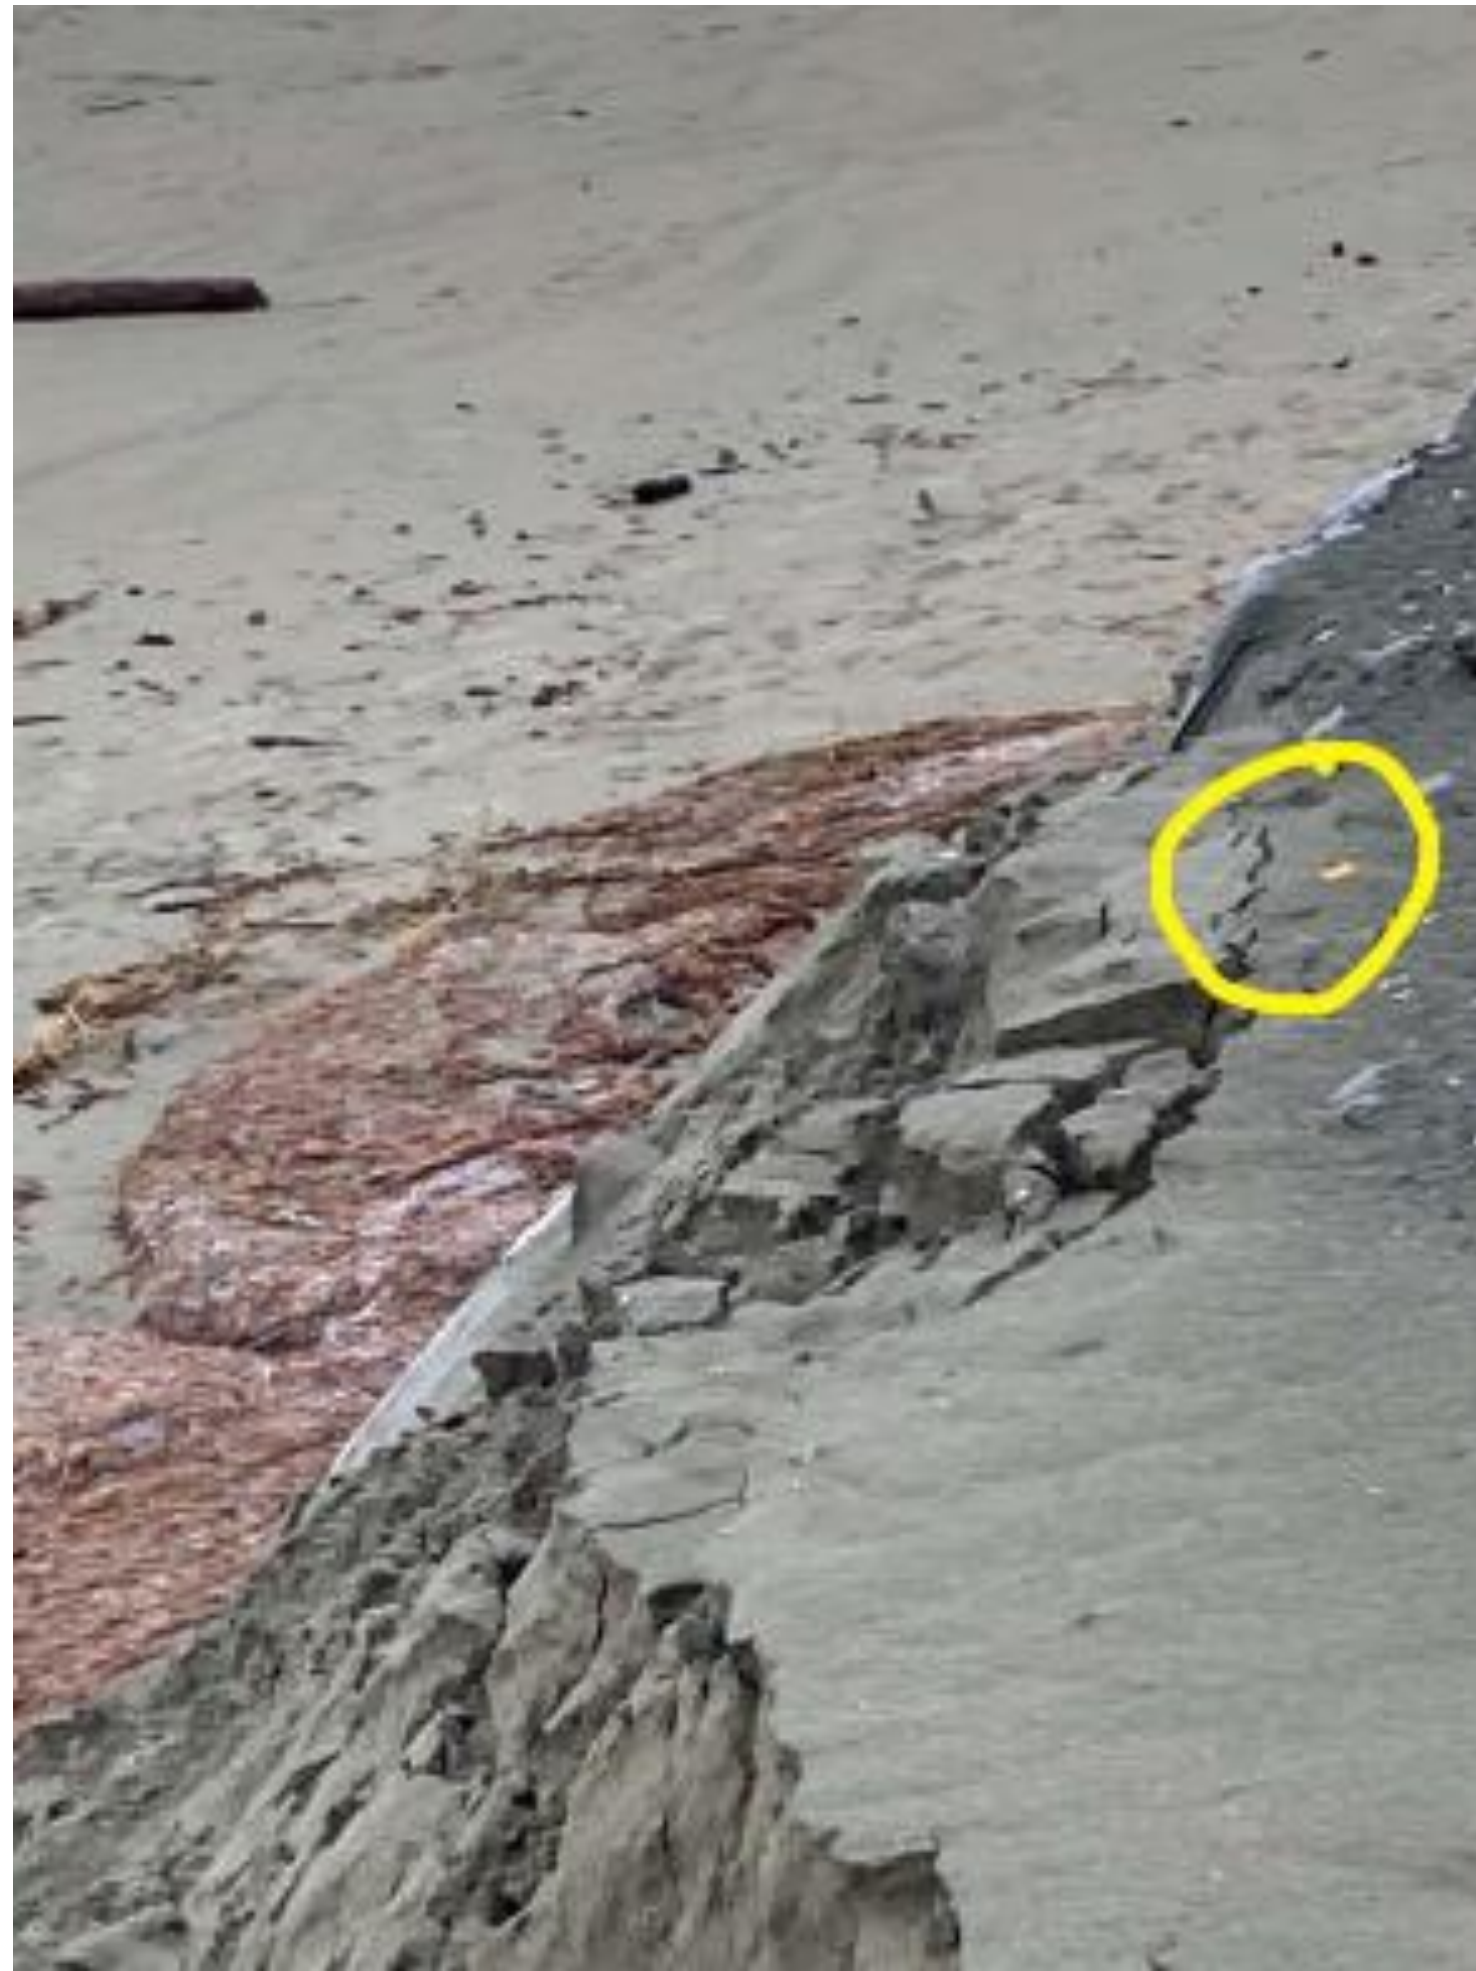
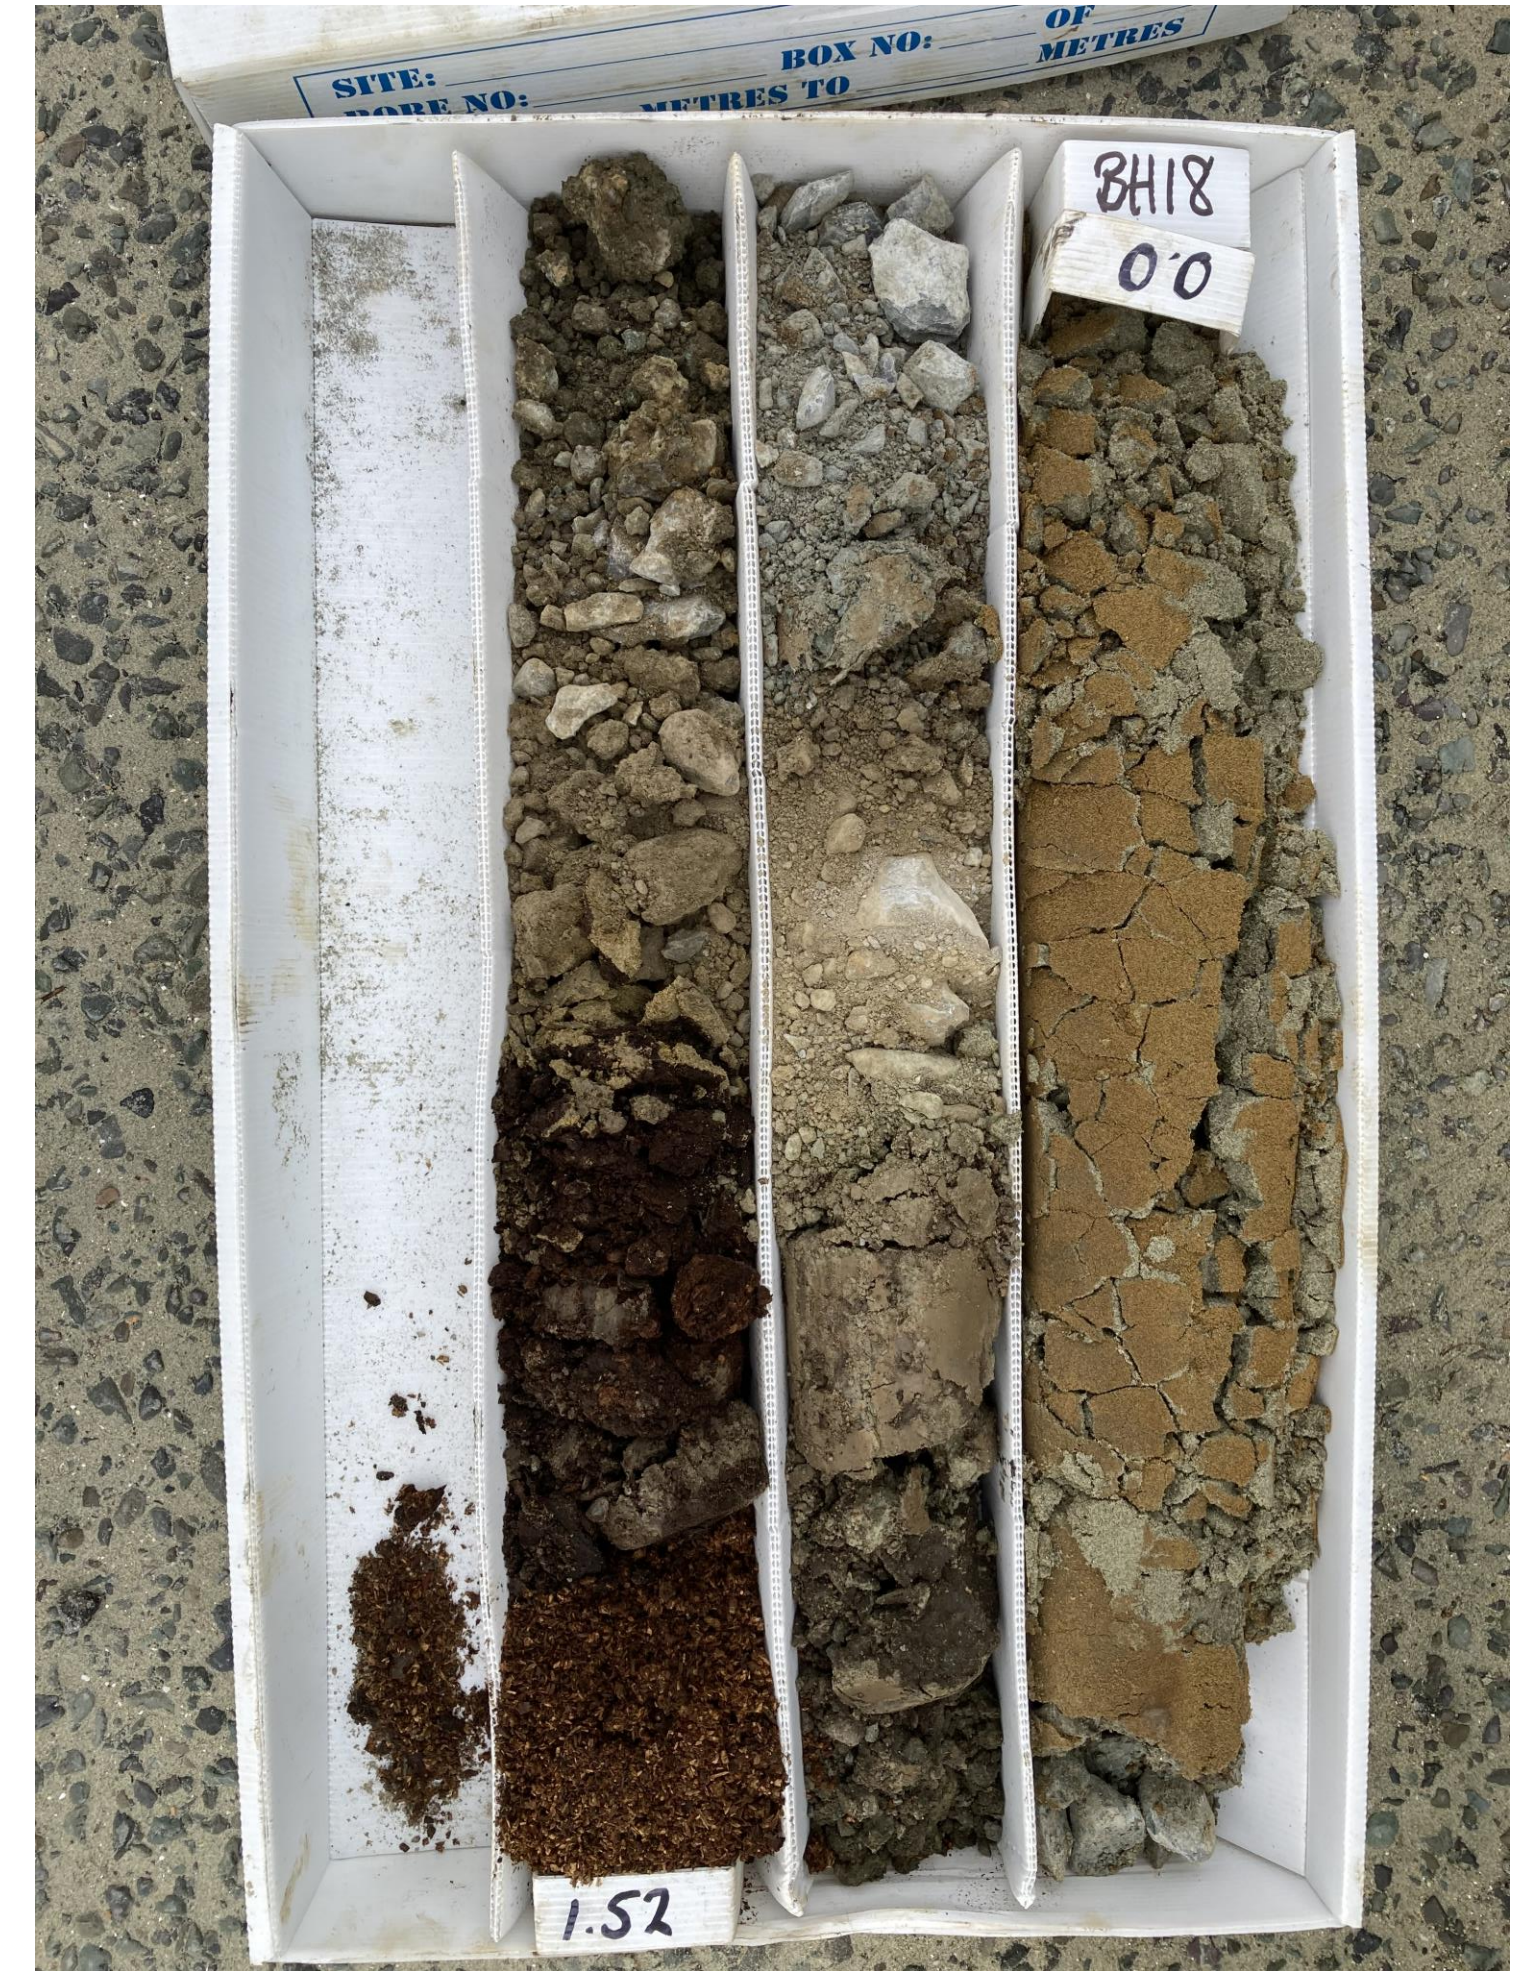
Detailed Site Investigation (2024): 26 boreholes and 179 arsenic tests

- High volume of sampling established arsenic had leached into sand underlying the sawdust.
- Arsenic concentration: 2 and 125 mg/kg

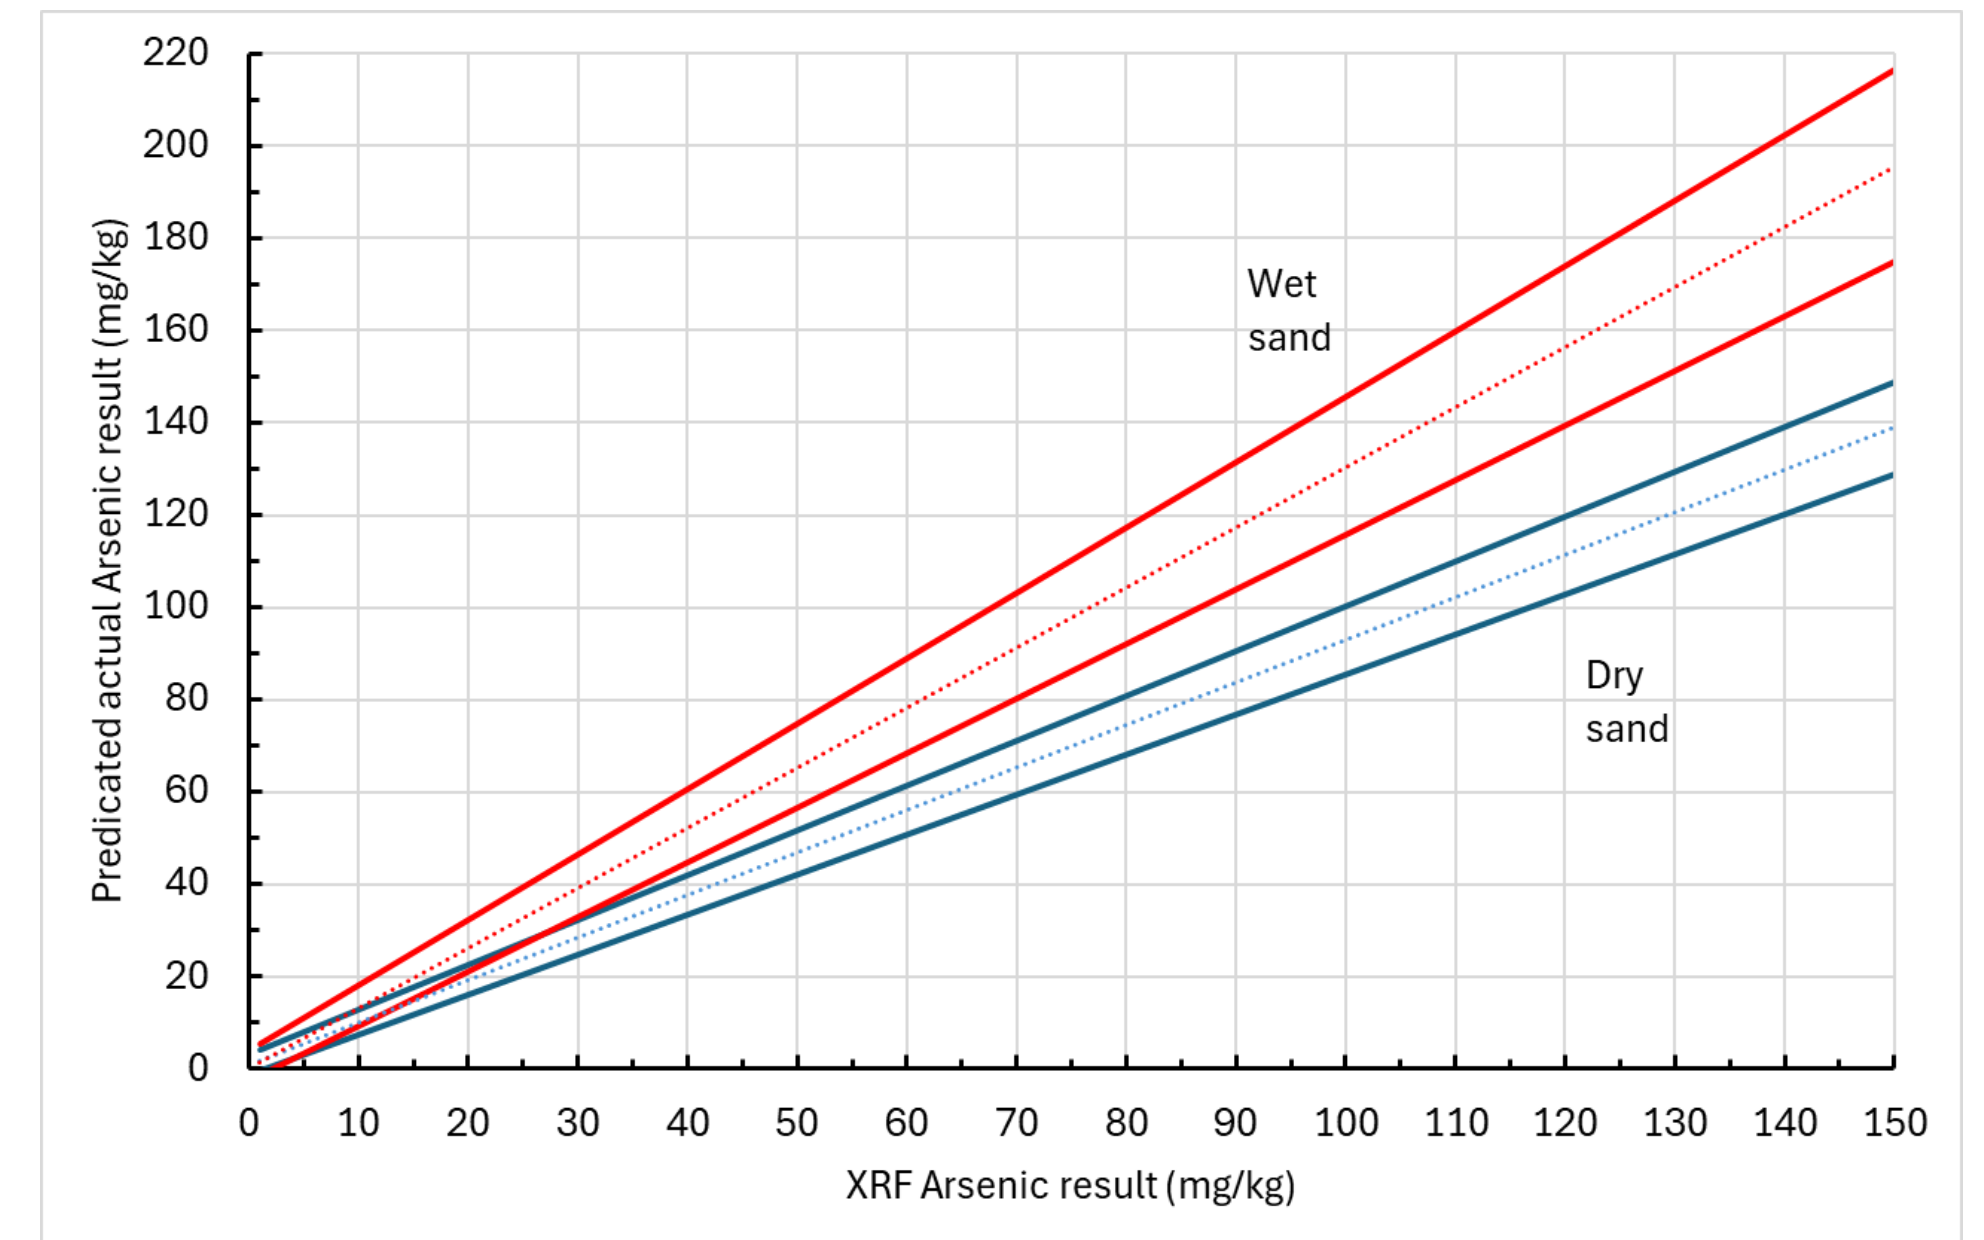
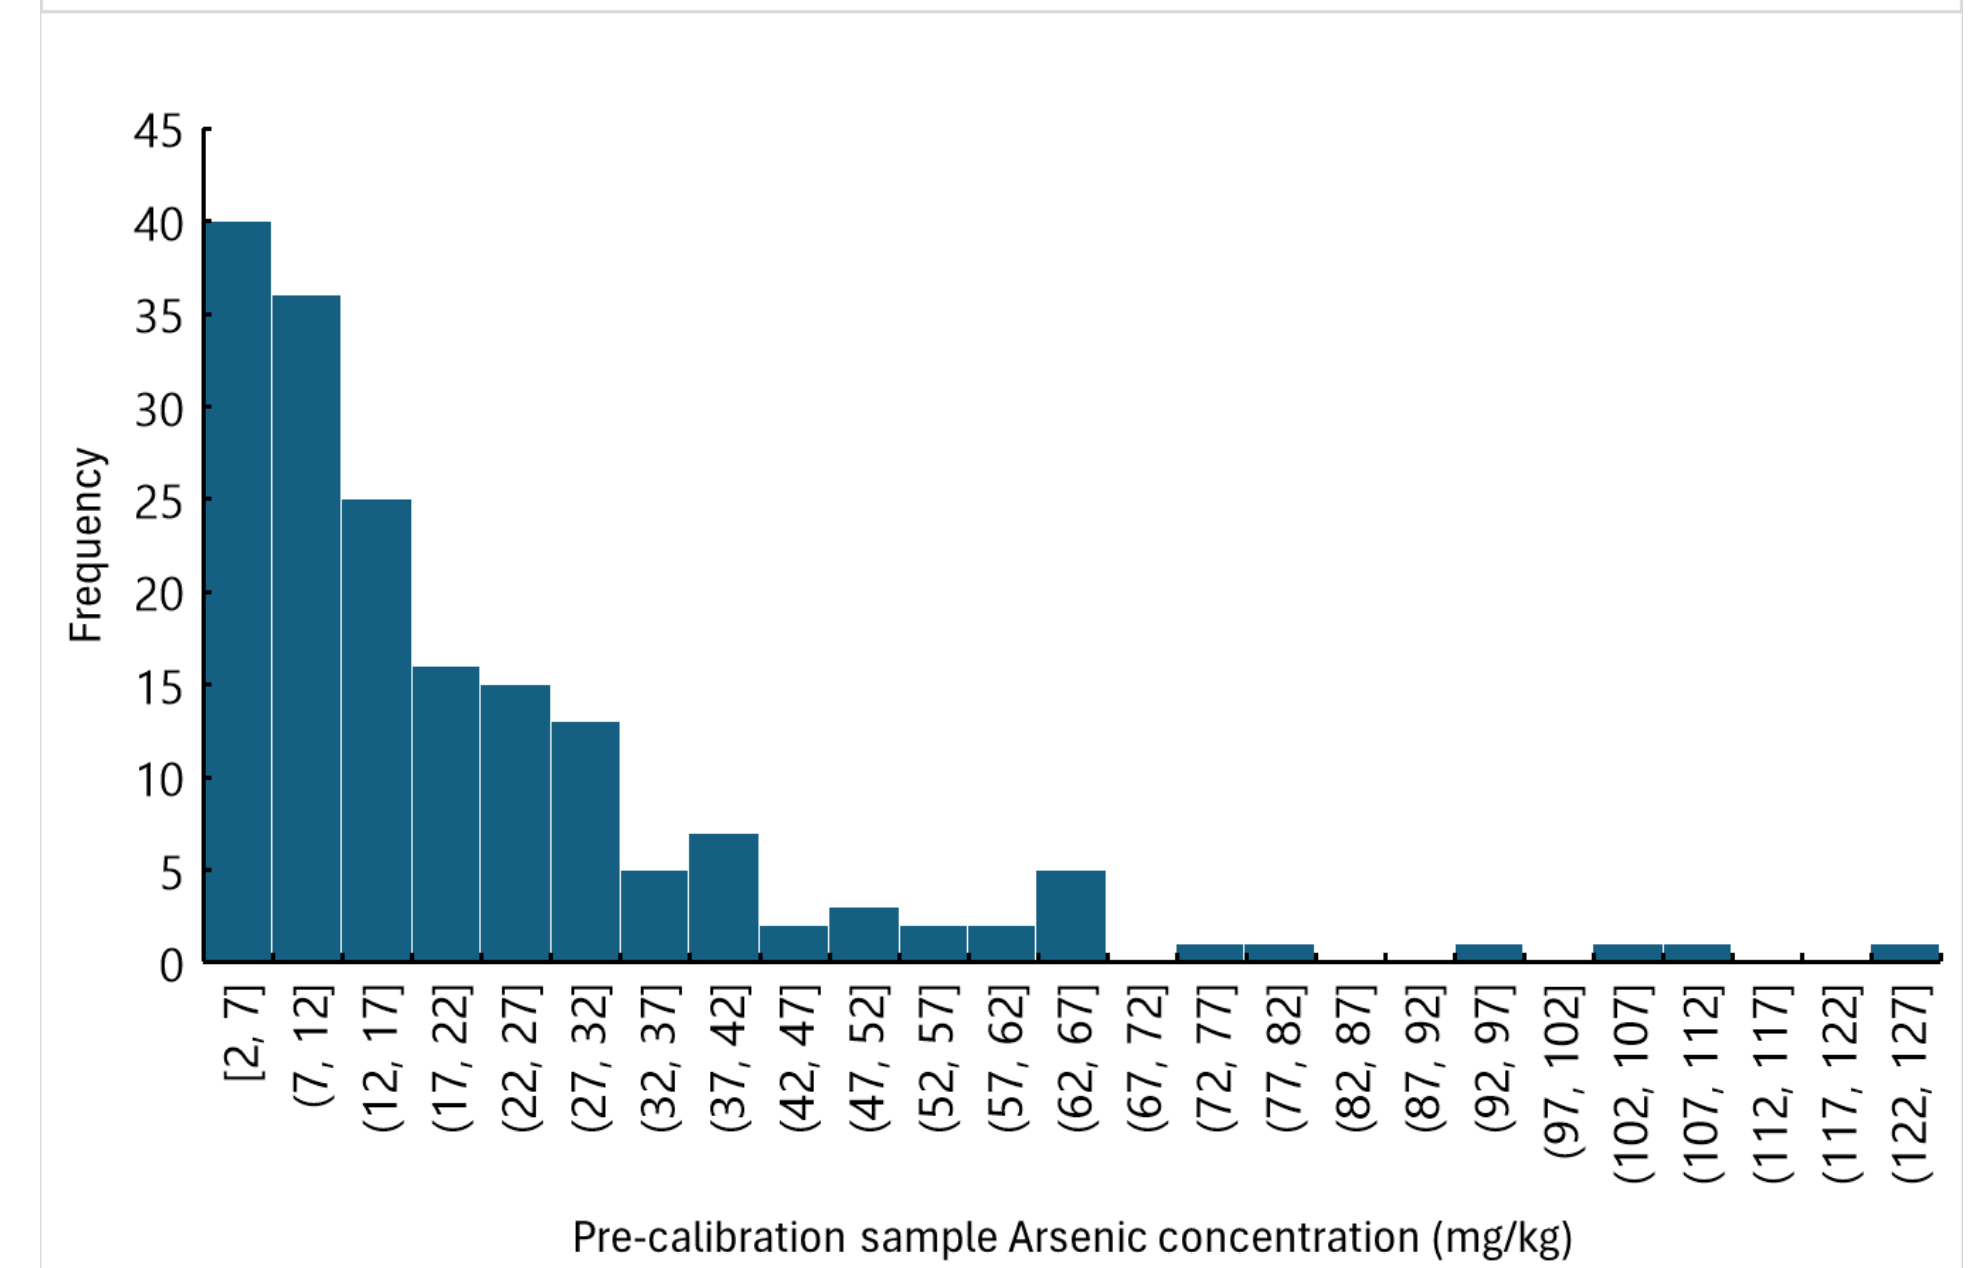
XRF Pre-calibration

- MfE guidance flags XRF accuracy issues on sand (damp sand) so pre-calibration designed to quantify/correct for this
- 89 sand samples held from the April 2024 investigation (Arsenic ranged 2–125 mg/kg, 90% results in 2–50 mg/kg range)
- Each sample scanned as-is and after wetting (three 1-minute scans per state, averaged)
- Regression analysis vs lab results:
 $R^2 = 0.937$ (dry), 0.847 (wet)
- Regression + 95% confidence interval converted into a field-calculator giving real-time predicted-lab-equivalent values during site validation
- Two Vanta units (M and S) used in pre-cal and intercomparison showed ~12–13% mean variance — acceptable for combining datasets. Vanta M used on site
