Sawdust and sandcastles: A tale of unexpected contamination

Miles Calder (Senior Environmental Scientist)
Sarah Guy (Environmental Consultant)

Site History and Project Overview

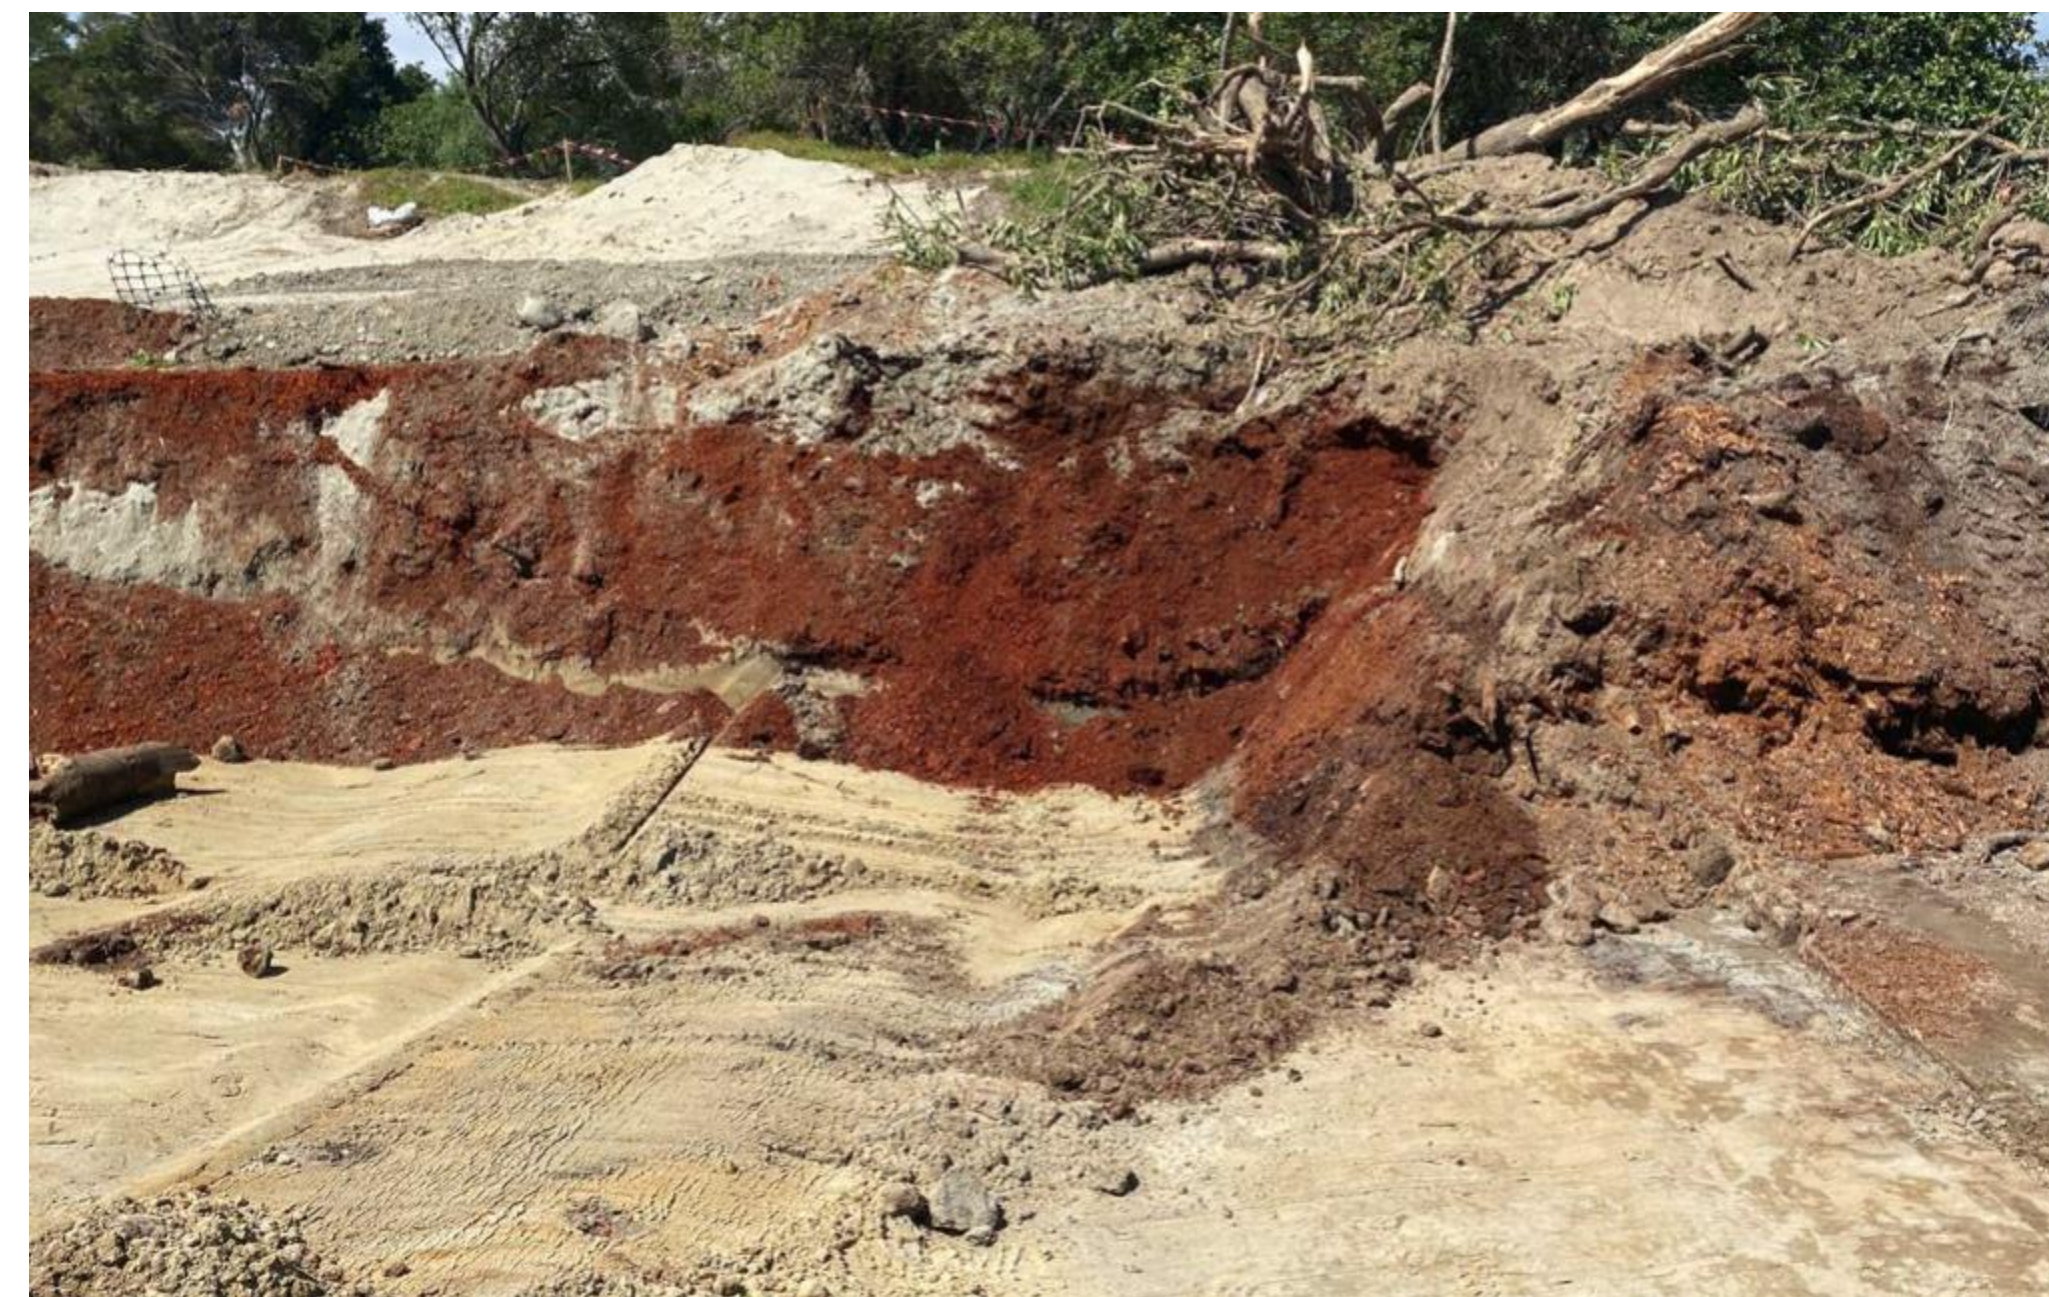
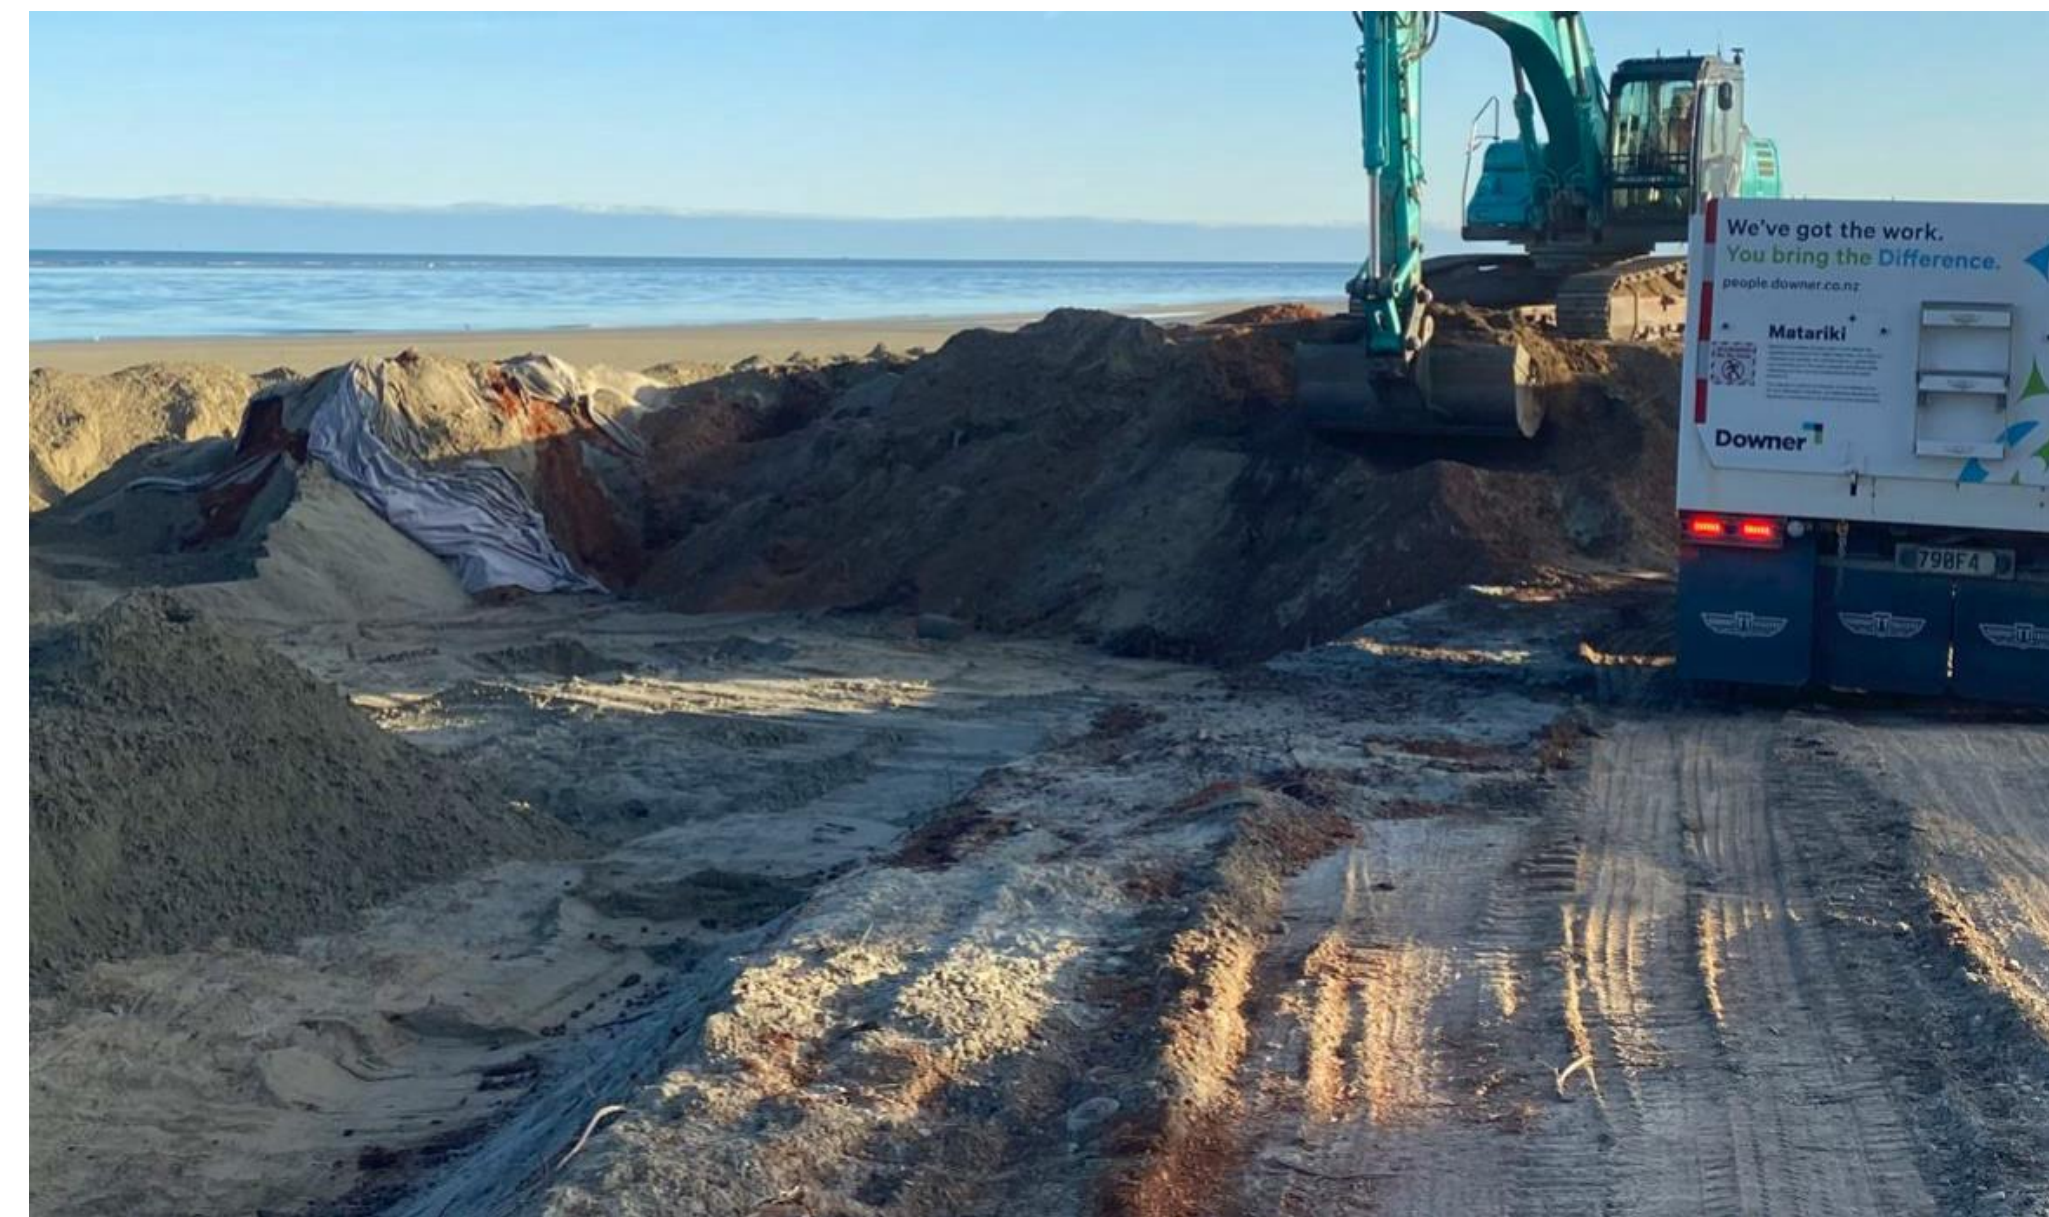
Site Validation

- XRF used on sand samples taken at 5 m intervals, 1 minute scans in triplicate
- All samples were able to be scanned relatively dry
- 184 samples analysed. Results maintained as a rolling average and adjusted to 'actual' based on upper 95% confidence interval of the linear regression
- Initial validation showed 3–205 mg/kg, mean 25.8 mg/kg
- High results triggered:
 - Additional higher density lateral delineation sampling
 - 0.1 m depth of elevated sand excavated and area retested. Repeated until achieving acceptable results before backfilling
- Validation following further excavation found:
 - Arsenic reduced to 3-65 mg/kg
 - No samples exceeded NESCS recreational (80mg/kg)
 - Estimated **mean 19.3 mg/kg** (below 20 mg/kg target)
