# Former Tokanui Hospital – Closed Landfill Investigation & Remediation Options Assessment

Dr Sean Finnigan & Elliot Bish, Fraser Thomas Ltd

# Closed Landfill

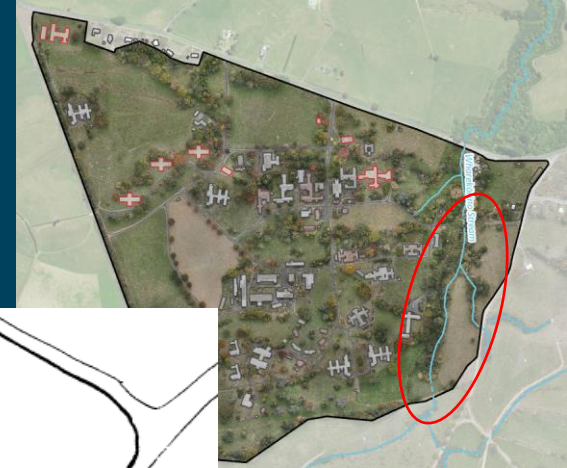
- Consented in 2000, consents expire in 2035: (AUTH102269.01.01, AUTH102270.01.01 and AUTH102271.01.01)
- Original AEE describes several distinct areas
- Used for different types of refuse
- Started ~1943 through to late 1980s
- LINZ retains liability in perpetuity, including maintaining consents

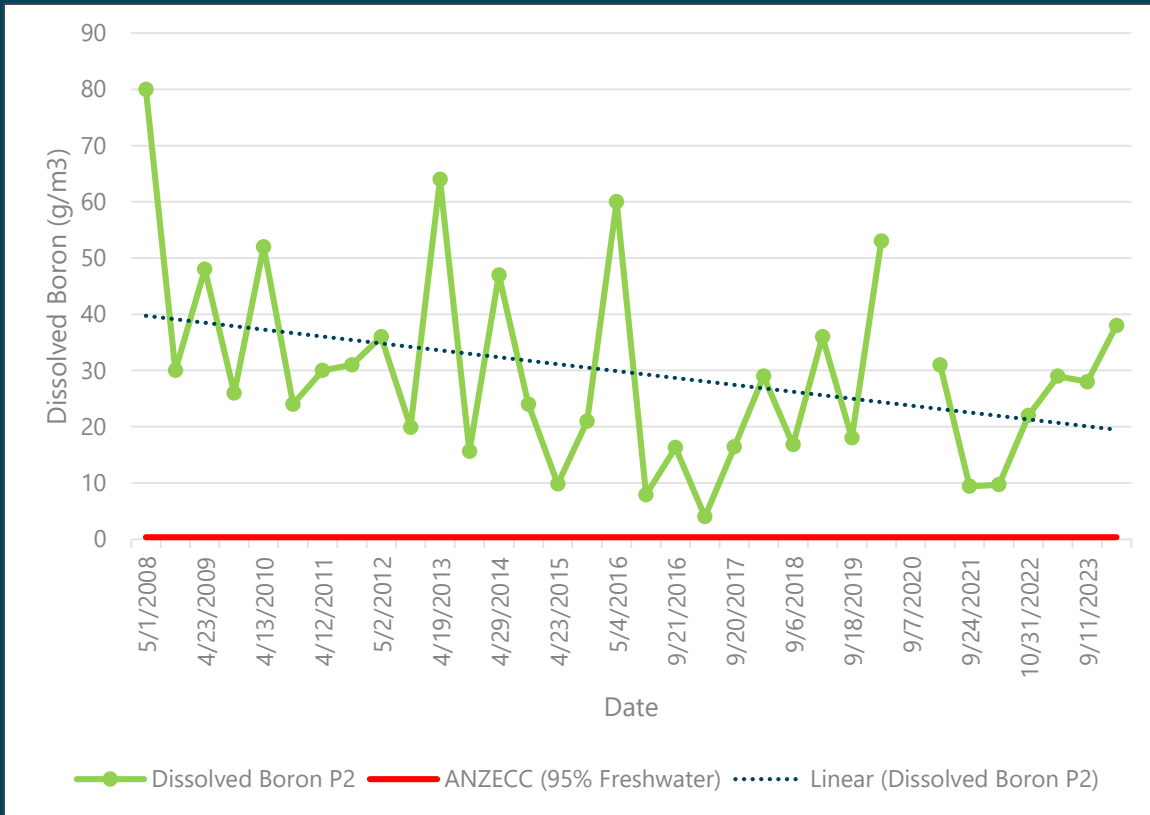
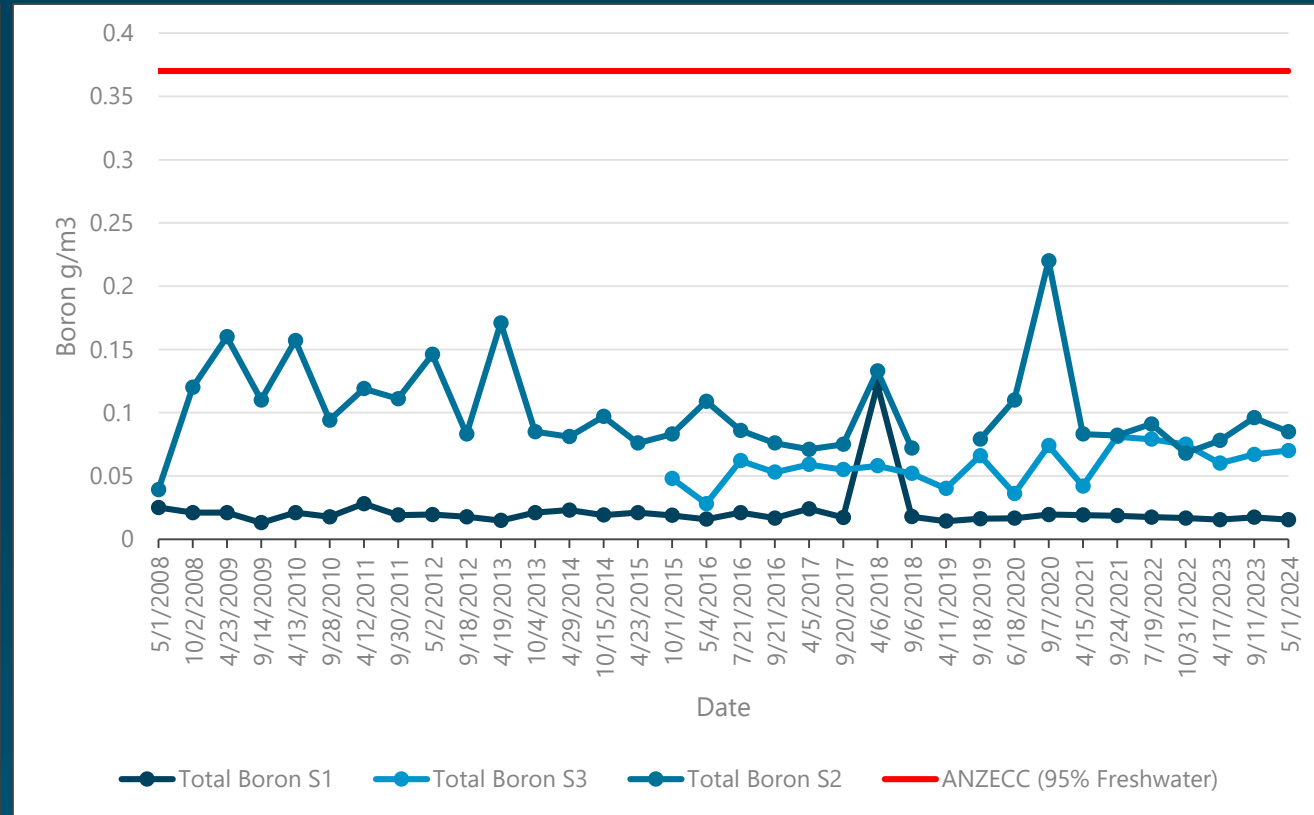
- Groundwater in contact with refuse + elevated boron.
- Elevated Boron in stream: S2 (downstream) > S3 (mid-stream) > S1 (upstream) but all within ANZECC 95%

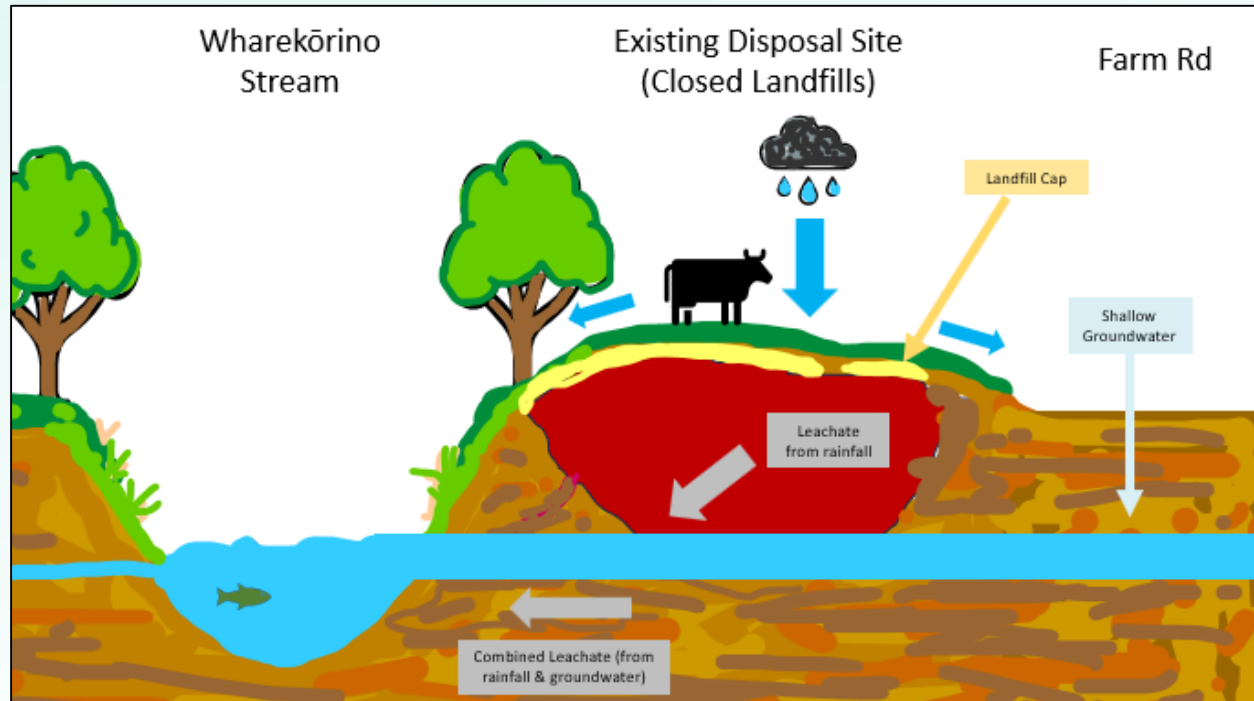
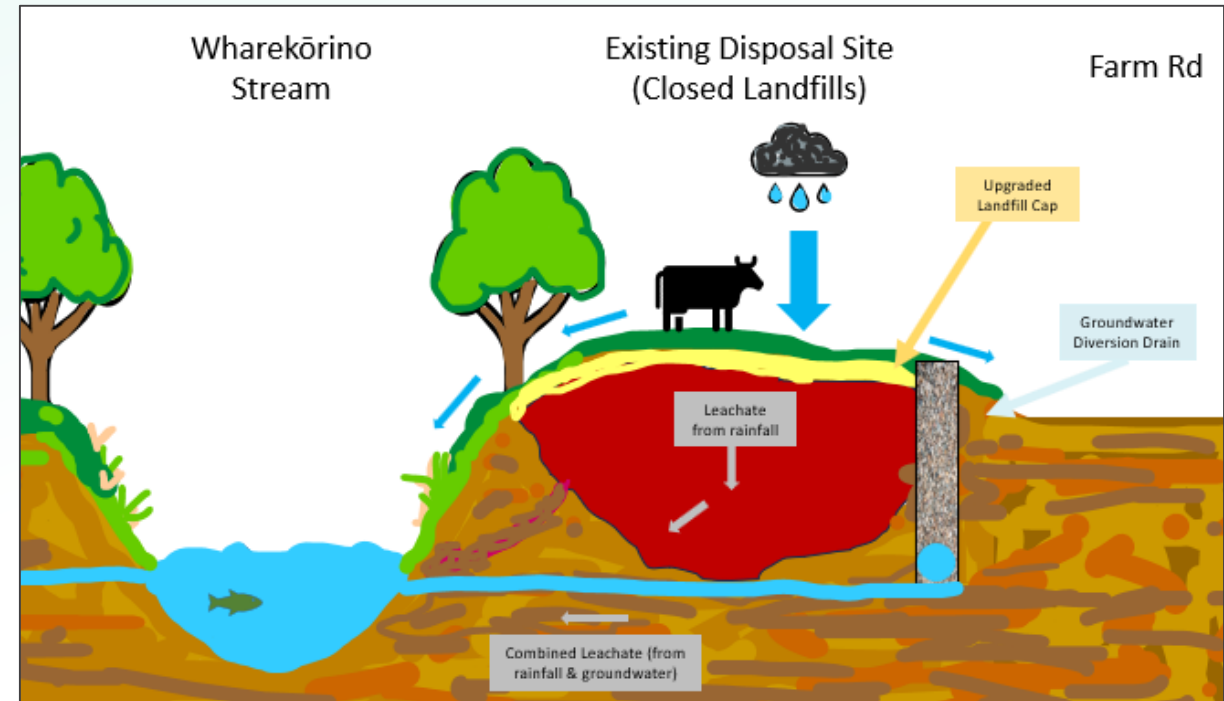
- Leachate discharges to stream estimated to reduce by 72-92%.
