When the Tide Goes Out

An asbestos risk evaluation for ACM
on an urban beach

Michael Mechaelis - Project Director | Tonkin + Taylor

Glendowie Bay East Auckland

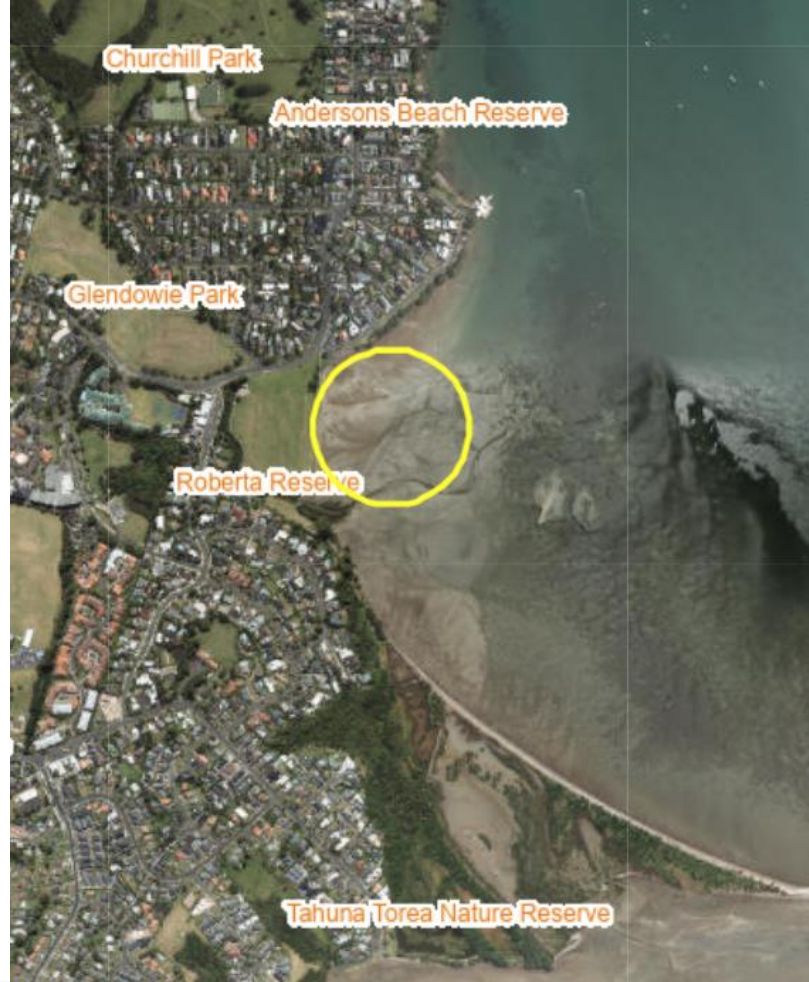
- Coastal Marine Area (CMA)
- Extensive sandy flats
- East - Roberta Reserve/ seawall
- South-east - Bird sanctuary
- North/ South - cliff faces

- History of ACM at surface
 - Public concern
 - Ongoing survey/ management
1. Where is/are the ACM sources?
 2. How is ACM being transported into/around the Bay?
 3. What risks to human health?
 4. How to manage?

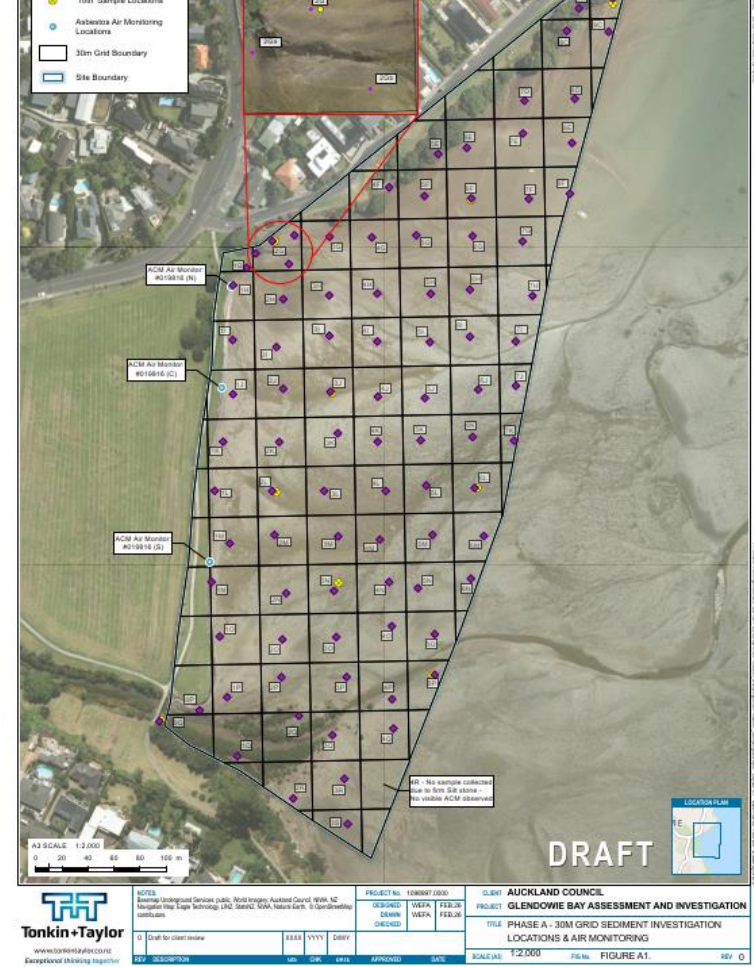
Site Investigation

- 26 sand + sediment samples contained ACM
- Potential exceedance Bonded ACM BRANZ Tier 1 guidelines
- AF/FA <0.001% w/w

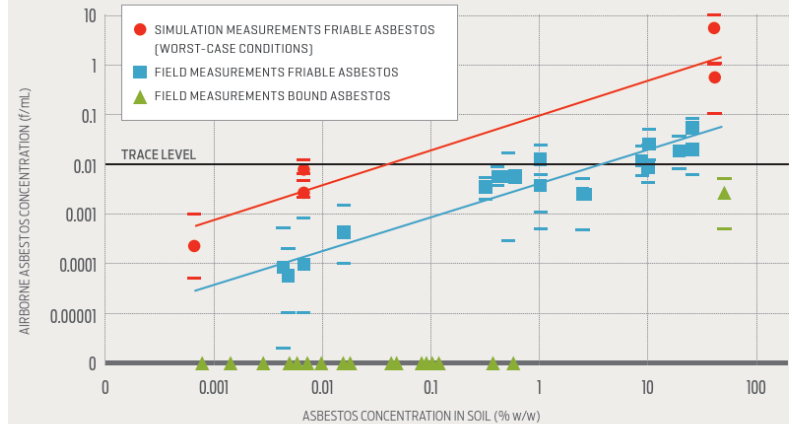
Figure 12. Asbestos fibre release in simulated and field measurements.

- Moisture content >10% in the dryest samples collected (14.6-37%)
- Based on Dutch asbestos in soil study there is low risk of ACM generating fibres that will become airborne

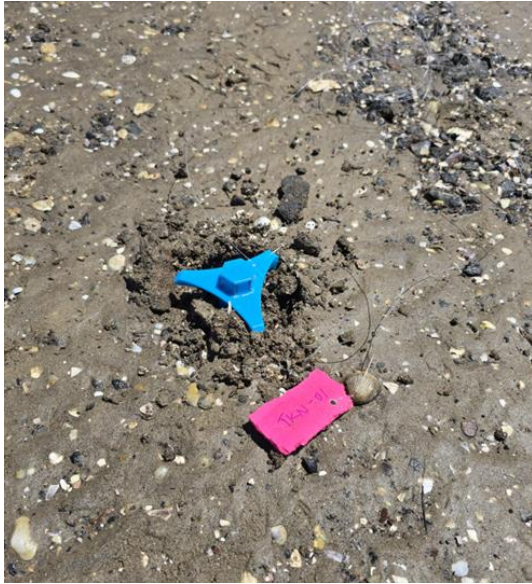
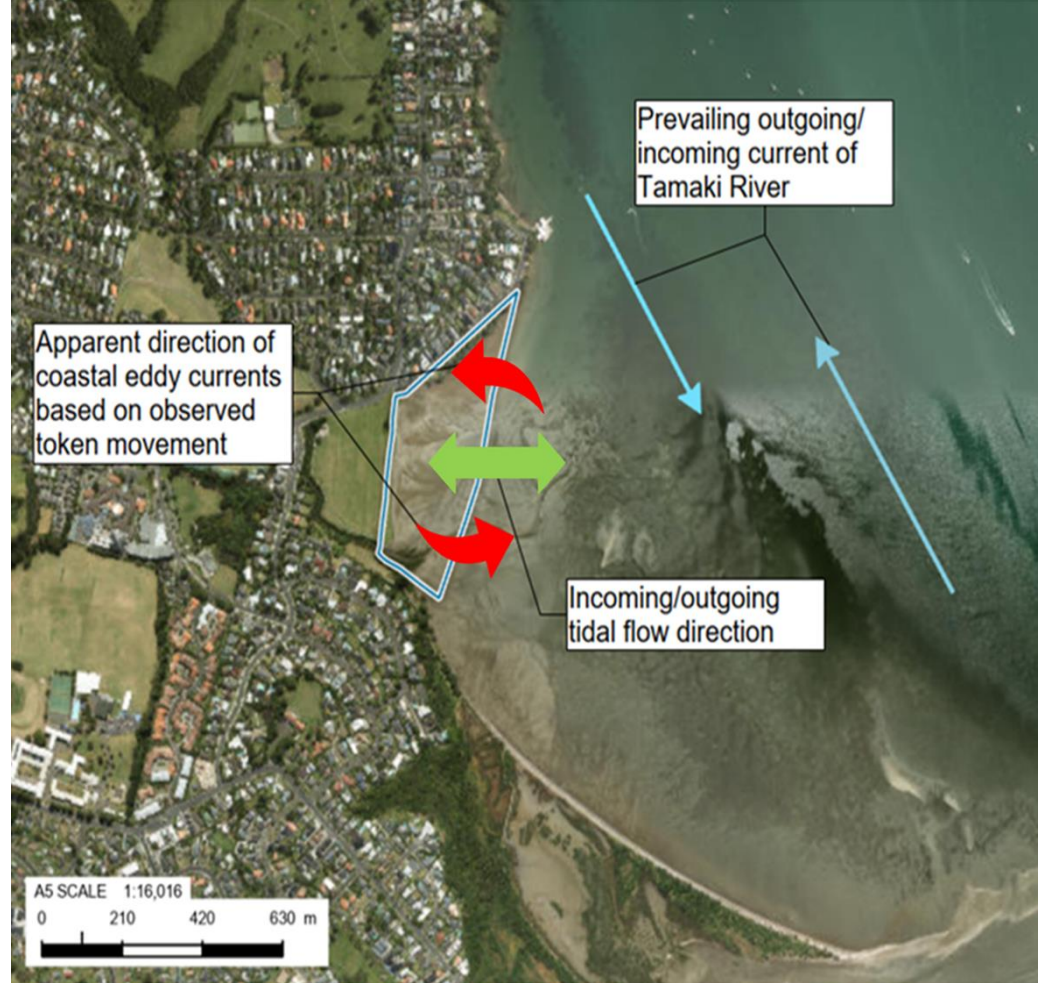
Tethered token modelling

Repeat accumulations
seen in NE part of the site
Why?

- fill in eroding cliff banks
- historical formwork under footbridge
- tidal mobilisation; current accumulation

- Liaison with Community engagement around findings
- Targeted action - known sources
- Management plan for ongoing periodic removals in Bay
