# Successful Revegetation of Closed Landfills

Graham Ussher<sup>1</sup> and Chris Hillman<sup>2</sup>

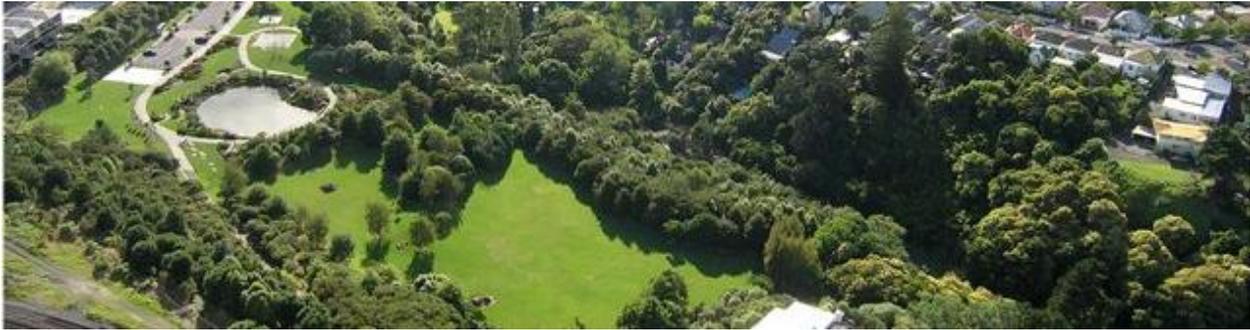
<sup>3</sup> Photo above – Aerial view of Newmarket Park Closed Landfill.

Slope stabilisation works on behalf of Auckland City Council are currently being undertaken at Newmarket Park in Parnell, Auckland. The park is a closed landfill surrounded by residential housing. In one area a steep slope, up to 25m high is unstable. The steepness of the slope combined with the nature of the landfill materials makes this slope prone to slips, of which many have occurred over the past 50 years. Slope instability threatens critical local drainage and sewer infrastructure and could also expose waste materials.

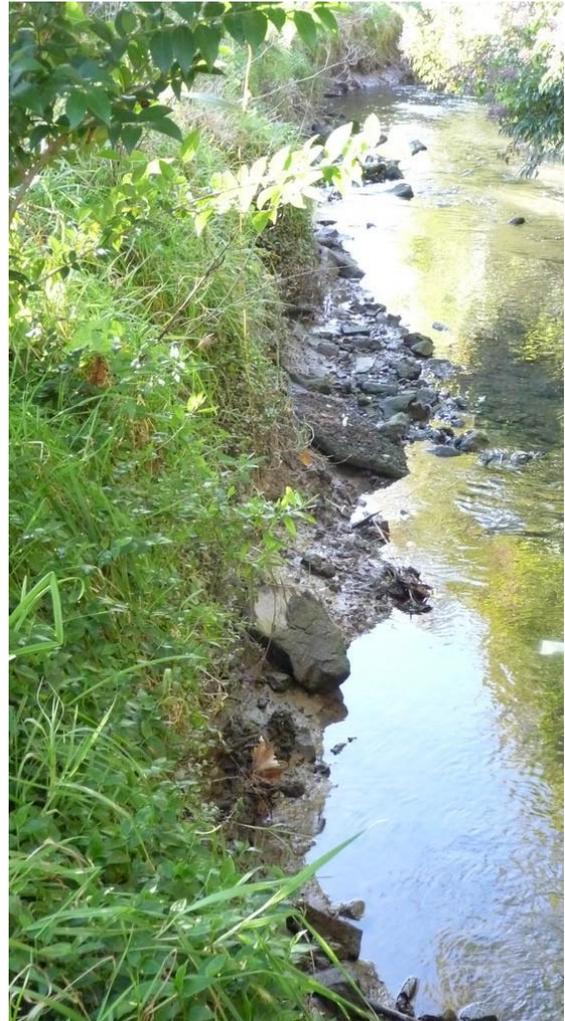
Meola Creek, Seddon Fields Closed Landfill

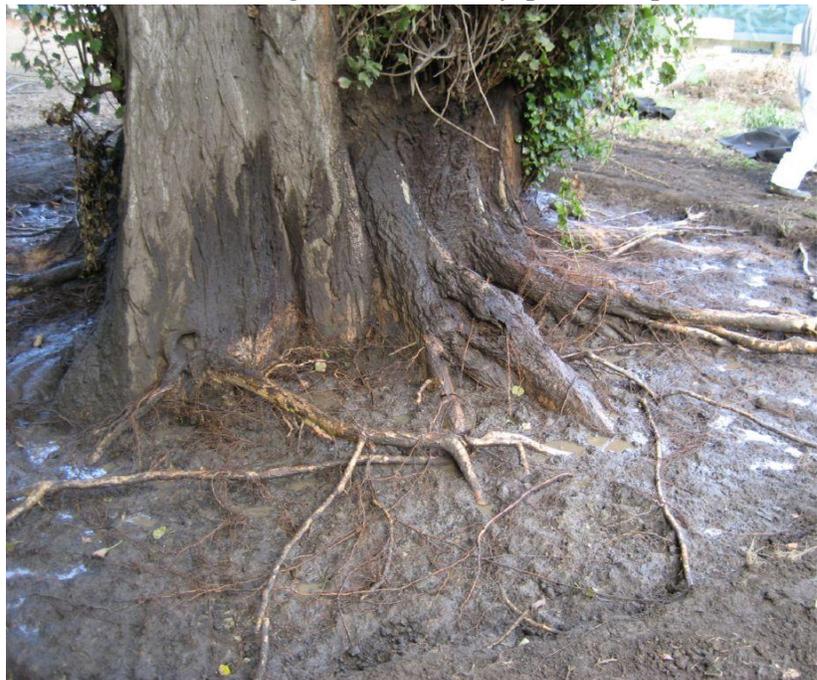
Air spading complete, Victoria Park

Air spades were used to excavate soils from above the main root bole, leading to less risk of damage to the root system and a higher probability of the tree remaining healthy. Although the air spading performed well in protecting the roots of the trees, the work took a number of weeks to

To enable a soil barrier to be constructed, 100 to 200mm of soil was removed from the surface. Excavation ceased when roots were encountered.

To enable air and water to permeate into the ground, 100mm to 200mm no fines concrete was placed over approximately the first 1m around the tree bole. Beyond this beneath the drip line, 200mm of scoria was placed, followed by a geotextile barrier, then 150mm of topsoil.

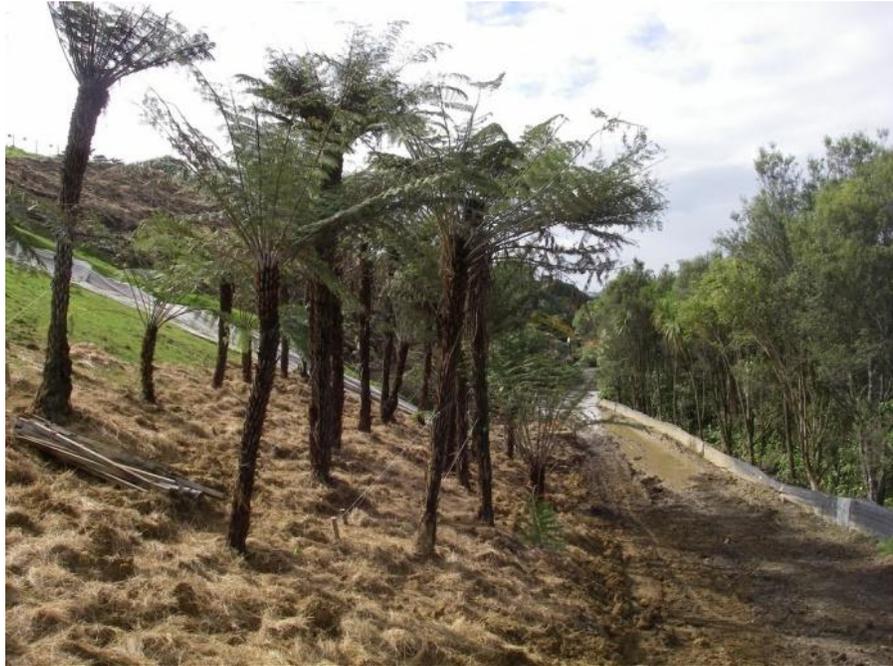
Planting of tree ferns, Newmarket Park

Mitigation proposed for the site included the establishment of diverse mature native forest including salvage and reuse of 50 mature tree ferns from the site, planting of 3m tall visual screening buffers for some residents and planting designs to cater for birdlife, protected wildlife (lizards) and health and safety of public using walking tracks.

4. Re-use felled logs to create refuges to encourage ground-dwelling lizards and insects to naturally recolonise the site quickly; and
5. Where trees are salvaged from the site (50 mature tree ferns) or where large-grade trees are planted for visual screens (e.g. several dozen 3 m tall natives), plant only specimens with shallow root plates to minimise the chances of roots penetrating the compacted clay barrier. Given that most native trees have root plates that are seldom deeper than 400 mm, the planting plans for the site were able to use a wide diversity of plant types, grades and forms to meet ecological, community and engineering needs.

Of interest for this case study was also the issue of cap penetration by associated activities. Relocation of the mature tree ferns and planned planting of large-grade trees require that plants are adequately staked to ensure stability. Typical means are by driving long stakes into the ground and securing the plants to them. In the case of Newmarket Park, such stakes would have penetrated the cap into the underlying wastes. Instead of stakes, trees were stabilised by running support wires to shallow-driven pegs within the capping layer.

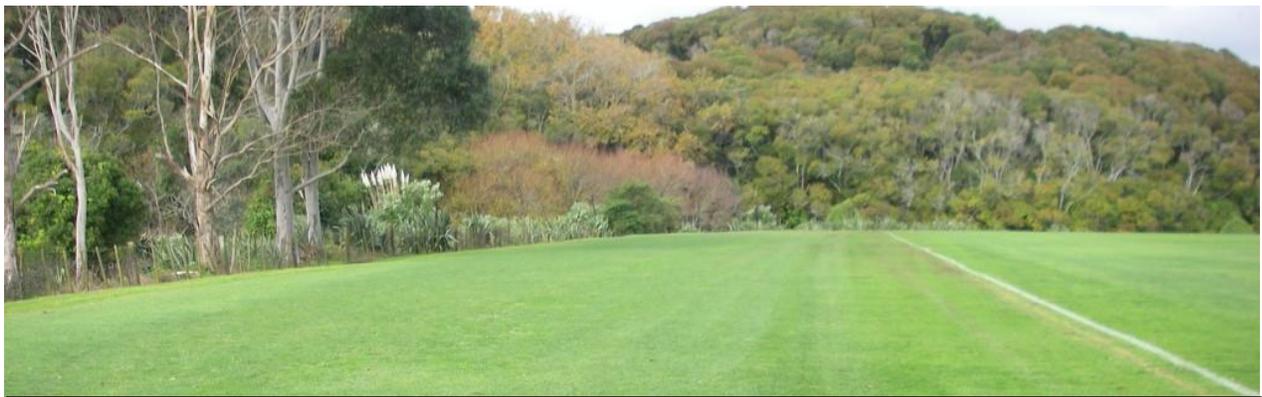
General view, Seddon Fields Closed Landfill

To maintain a barrier between wastes and the public, where the cap is thin, 300mm of materials are planned to be deposited. In addition, the whole planted area will be topped with 200mm of mulch to provide a friable, organic-rich growing medium for the native plants. These measures have also been employed to reduce the chance of roots penetrating through the capping materials and into the underlying waste. To maintain the gas-permeability, organic growth medium (e.g. topsoil and mulch) will be used (up to 300mm thick) where landfill cap thickness needs to be increased to provide a barrier or where a suitable growing medium for the planting needs to be provided.

Where public access is proposed, footpaths have been designed to form a barrier between people and the underlying landfill materials (eg a compacted metal track). In some areas, excavation into the cap will be required to construct the paths and these areas will be undercut by 300mm and infilled with engineered capping materials to form a physical barrier. Fences will be provided to restrict public access away from paths where planting is not dense enough to discourage people from walking off the tracks and into areas of thin capping.
