# Te Wai Takamori o Te Awa Kairangi

## Sustainable Soil Reuse

Suzanne Lowe  
Associate Director – Environment  
AECOM

# Case Study 1: Rail Ballast and Reuse

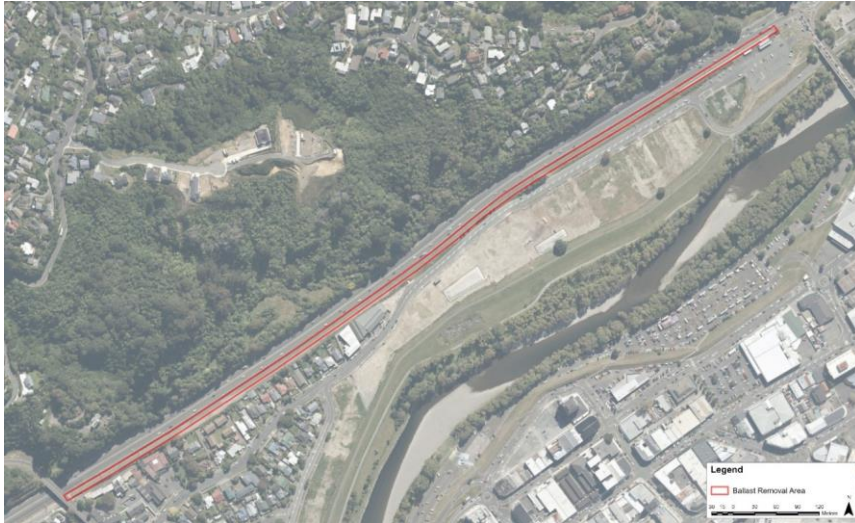
- What do you do with approximately 3,000 m<sup>3</sup> of potentially contaminated rail ballast....

- The Alliance recognised this as a key opportunity for sustainable re-use within the Project.

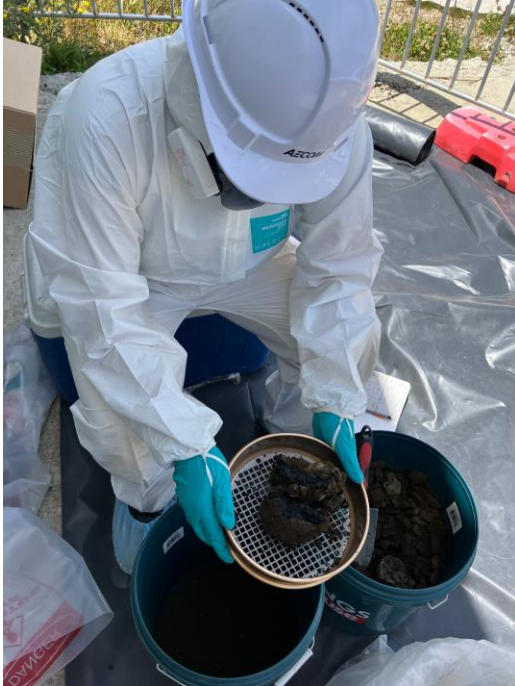
To assess suitability for reuse:

- Does ballast meet geotechnical requirements for re-use within the project;
- Ballast sampling and testing;
- Tier 2 Risk assessment;
- Communication and agreement with regulators.

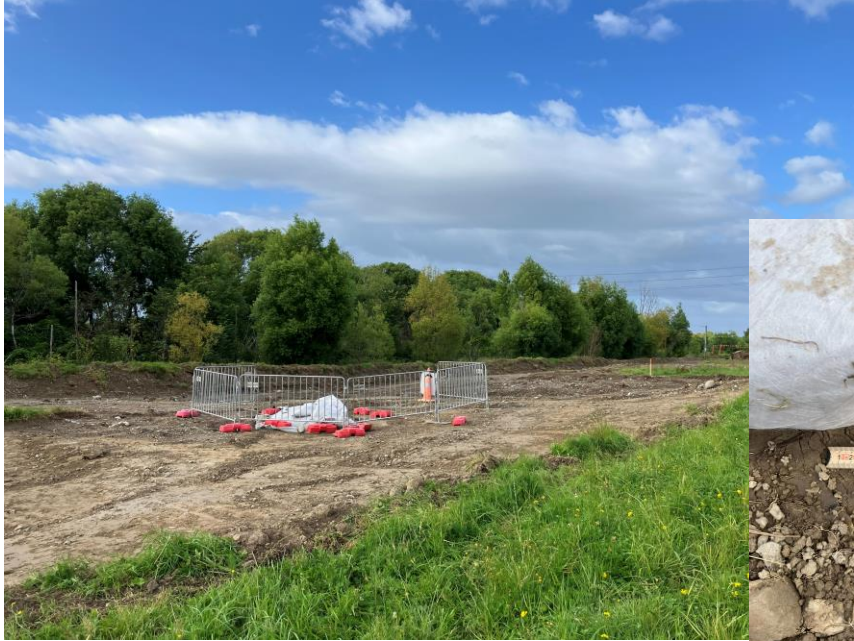
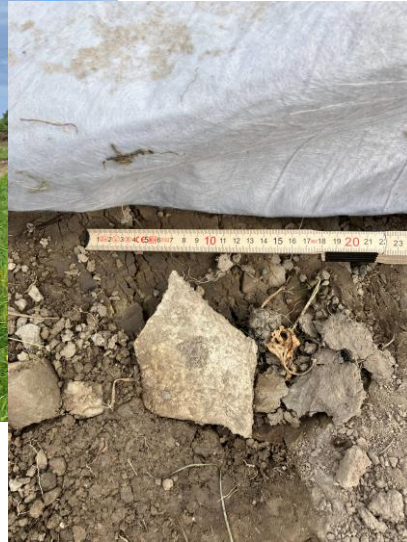
- During top soil stripping contractors identified bulk ACM fragments and immediately stopped work
- Undertook surface visual assessment to define area

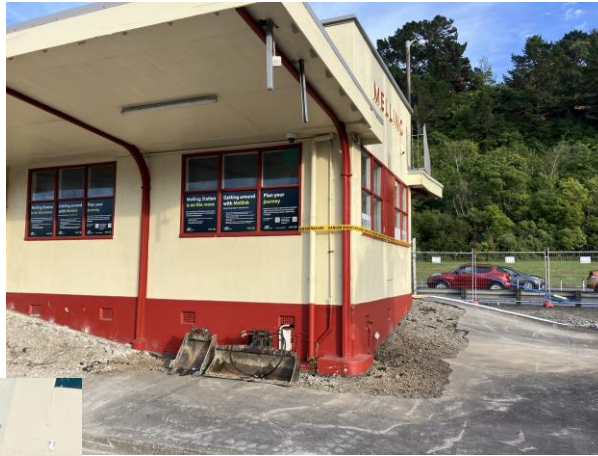
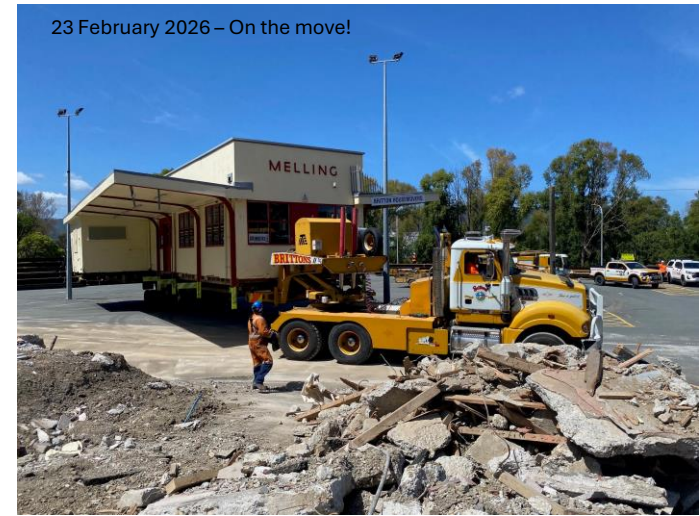
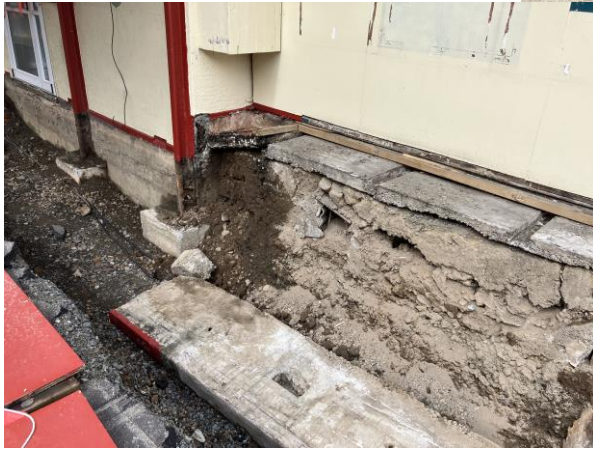
- Asbestos dust in ceiling removed by licensed removalists
- Building 1m halo then excavated so the building could be relocated

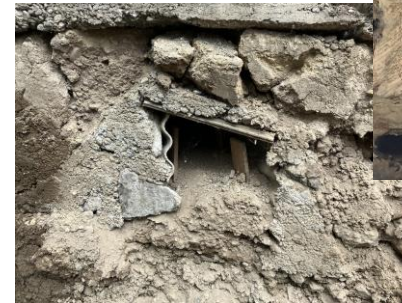
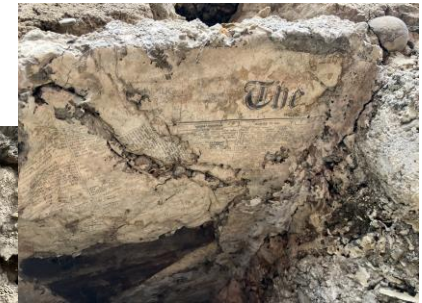
- During building relocation prep ACM discovered in building vents
- Bulk ACM removed by licensed removalists

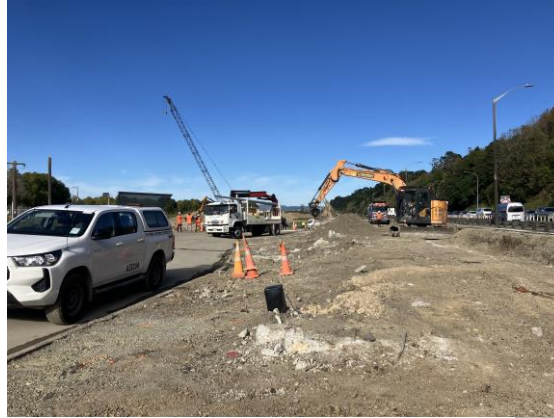
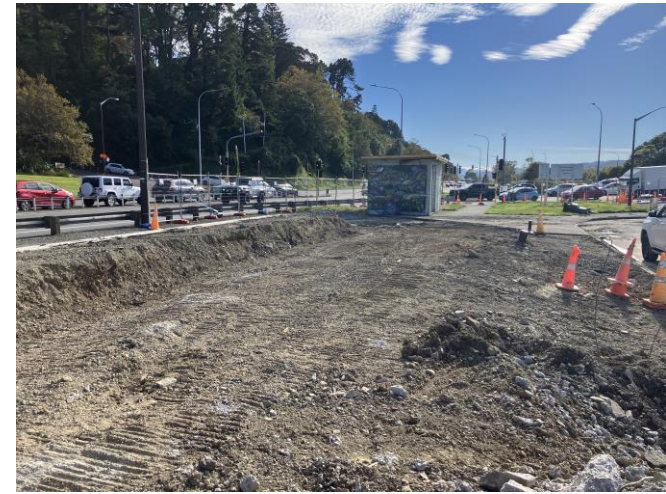
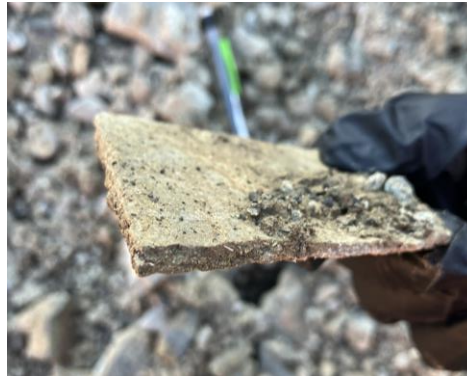
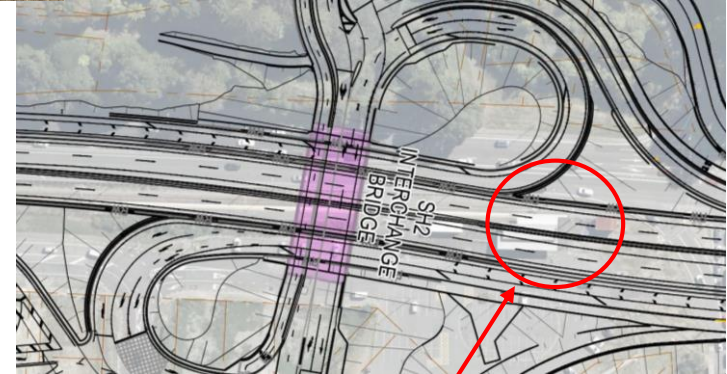
Former Melling Station

- Further ACM discovered in post building soil sampling under footpath area
- All material retained within building footprint
- Final design has former Melling Station under approx. 4m fill material and under centre of SH2 alignment

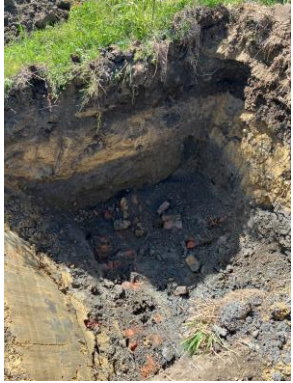
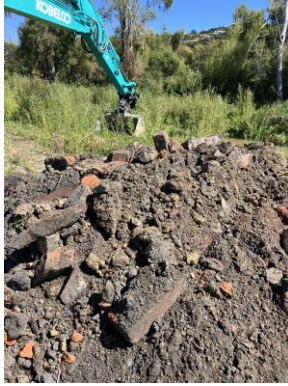
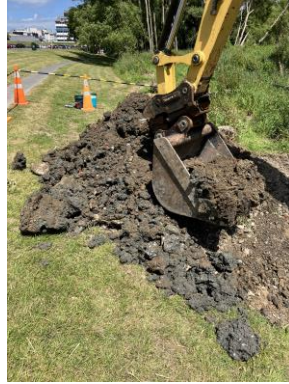
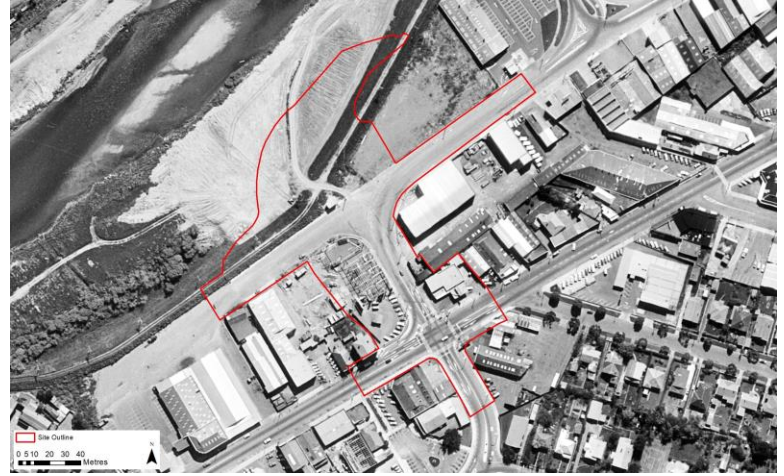
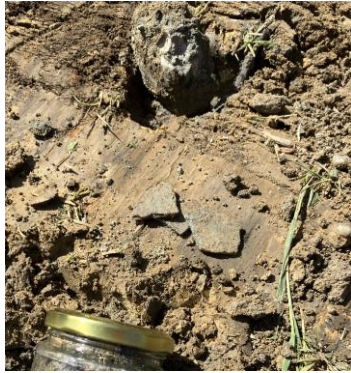
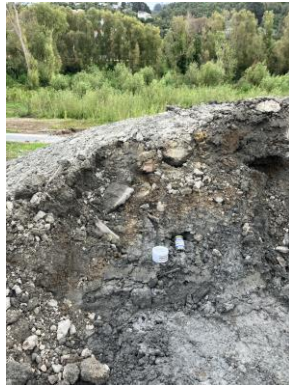
- Fill material circa ~1950's-1960's
- Material geotechnically unsuitable for reuse on site (wet, high clay & silt content)
- Bulk ACM in test pits and AF/FA in stockpile samples

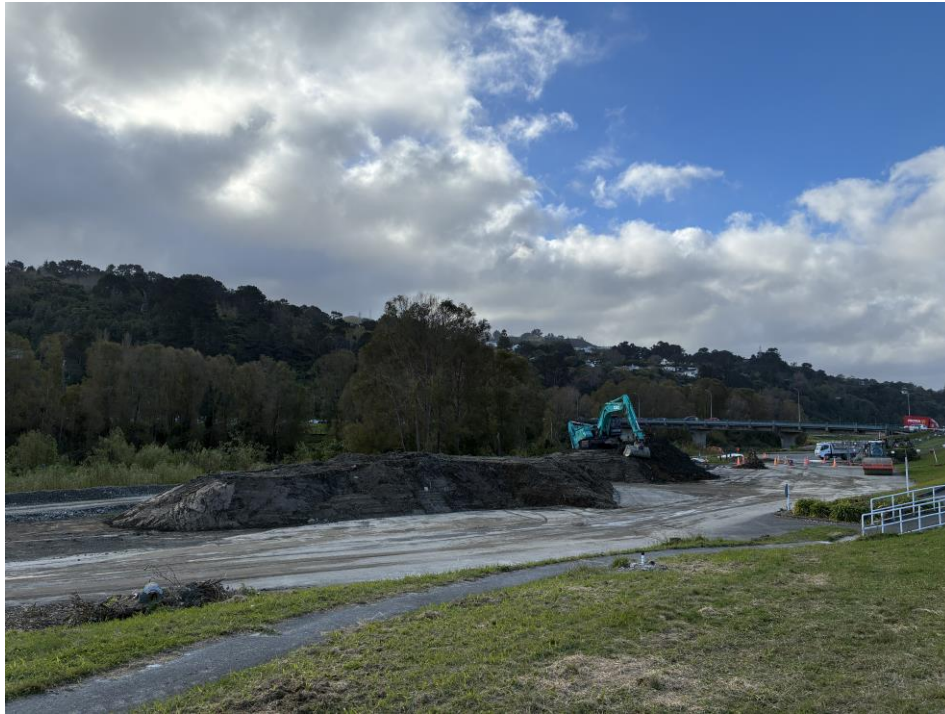
- Stockpiles being removed off-site to Class 1 landfill
- ~1150T material, ~25T per truck & trailer.. 46 trips to the landfill = \$\$\$
