**RECYCLING OF END-OF-LIFE TYRES IN CIVIL ENGINEERING APPLICATIONS:
ENVIRONMENTAL IMPLICATIONS**

Laura Banasiak^{1}, Gabriele Chiaro², Alessandro Palermo², Gabriele Granello²*

Eco-rubber seismic isolation foundation system project

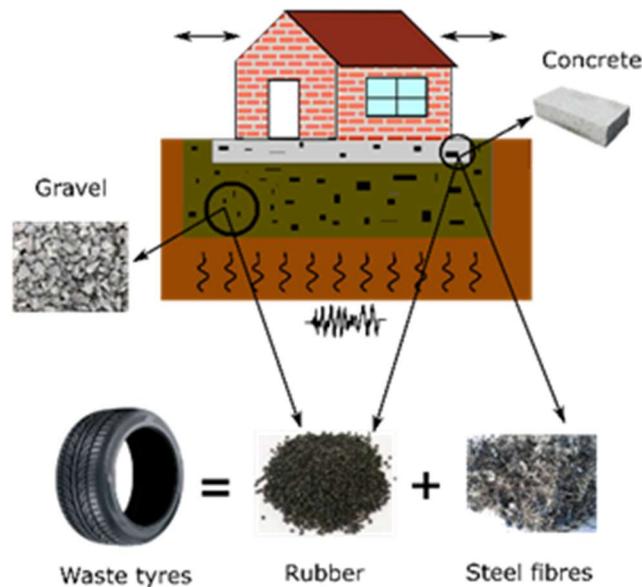
A comprehensive geo-environmental-structural experimental research programme, funded by the MBIE Smart Idea research programme, is currently being carried by the Institute of Environmental Science and Research Ltd (ESR) and the University of Canterbury to investigate sustainable options for the reuse/recycling of waste tyre in civil engineering applications. The project will investigate a cost-effective seismic resilient engineered foundation-soil system for low-to-medium-density low-rise residential housing composed of a) a shallow layer of mixed shredded tyres (in the form of granulated tyre rubber (GTR)) and gravel, and b) a flexible rubber-concrete raft foundation (Figure 1).

Figure 1. Eco-rubber seismic isolation foundation system.

4. *Numerical models* to optimise the proposed foundation system (i.e. rubber-gravel mixture thickness; thickness of rubber-concrete foundation structure; possible use of alternate layers of rubber-gravel and rubber-concrete) and provide insights on the micro-mechanical shear and compressible behaviour of gravel-rubber mixture and their interaction under external applied loads;
